Testing of Electric Flash Railhead Repair Welds at FAST

Daniel Gutscher and Joseph LoPresti

Summary

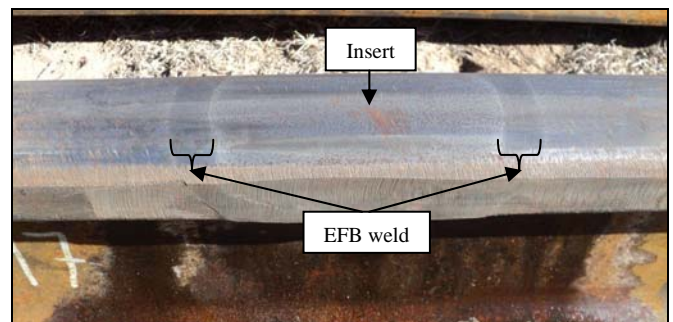
weld has been etched to reveal the macrostructure at the running surface. An HDR weld consists of a single flash weld that intersects the running surface at two locations, approximately 6 inches apart (this is larger than the initial cut due to flashing of the insert into the rail). Figure 4 shows a vertical longitudinal cross section of a completed weld.

Figure 3. Completed Weld with etched Railhead revealing Running Surface Macrostructure

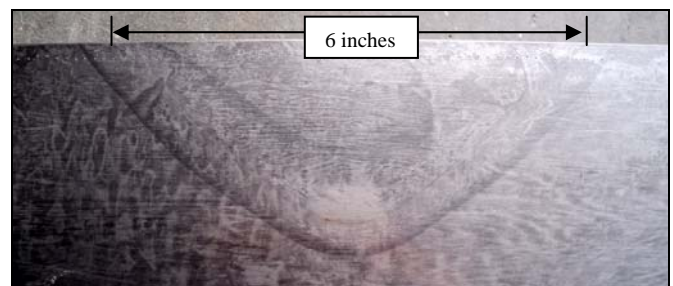
Figure 4. Vertical Longitudinal Cross Section of HDR
