Testing of Thermite Welds with Treated Heat Affected Zones

Megan Archuleta, Daniel Gutscher, and Joseph LoPresti

Summary

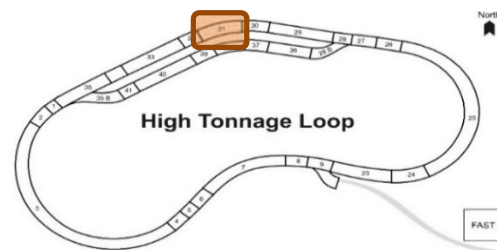
Figure 3. Installment Location of the Thermite Overlay Treatment of the HAZ Welds on the High Tonnage Loop

In July 2012, 21 welds were installed in track at FAST in Section 31 of the High Tonnage Loop (Figure 3). Nine were conventional welds from each supplier (three untreated and six treated) and three were HAWs (two treated and one untreated) from Supplier B.
