# Second-Generation Head Defect Repair Weld Testing at FAST

## Summary

**SECOND-GENERATION HDR WELDS**

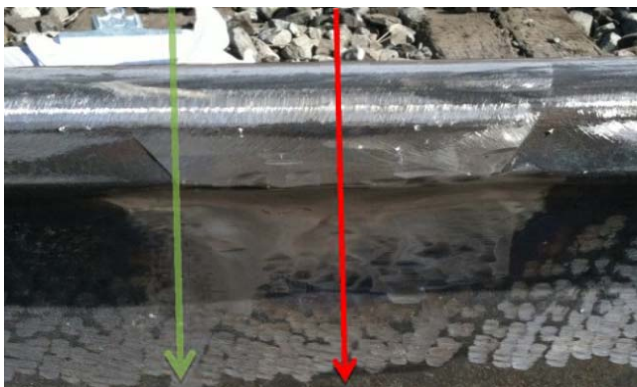
TTCI engineers conducted residual stress testing on three of the head defect repair welds containing smaller NDT indications of 1- to 3-percent CSHA to try to determine whether residual stresses could have contributed to the weld failure. For all of the three welds, the rail cuts were made transverse to the rail at 0.25 inch from the strain gages (Figure 6).

**Figure 6. Second-Generation HDR Weld after Production**  
(Red arrow shows the vertical cut direction down the center of the insert for Weld Nos. 1 and 2; the green arrow shows the cut direction at the point where the left bottom corner of the insert meets the bottom of the railhead for Weld No. 3.)

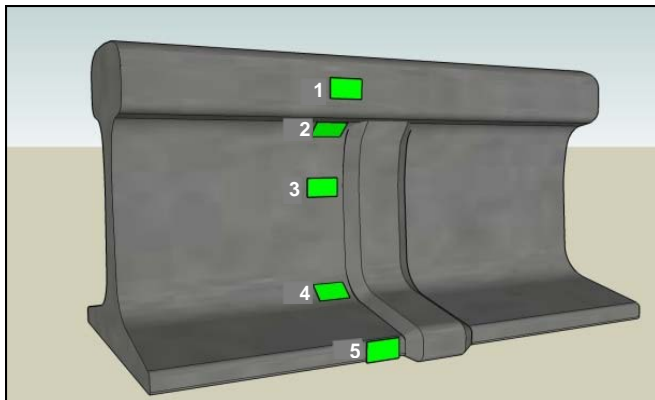
Each residual stress test weld was equipped with seven strain gages placed next to the weld as Figure 7 shows. At these seven locations, the pre- and post-cut micro-strain was recorded by the train gages and converted to residual stresses.

**Figure 7. Example View showing the Placement of Strain Gages attached to a Thermite Weld**

Strain gages were placed in similar arrangement for the railhead repair welds. 1. Side top center of railhead. 2. Side of the railhead. 3. Rail neutral axis. 4. Center of radius between the rail web and foot. 5. Tip of the base flange. Not shown were strain gages placed at the top of rail and at the bottom center of the rail foot.
