# Analysis of Turnout Failure Modes in Revenue Service

Benjamin Bakkum, David D. Davis, and Rafael Jimenez

## Summary

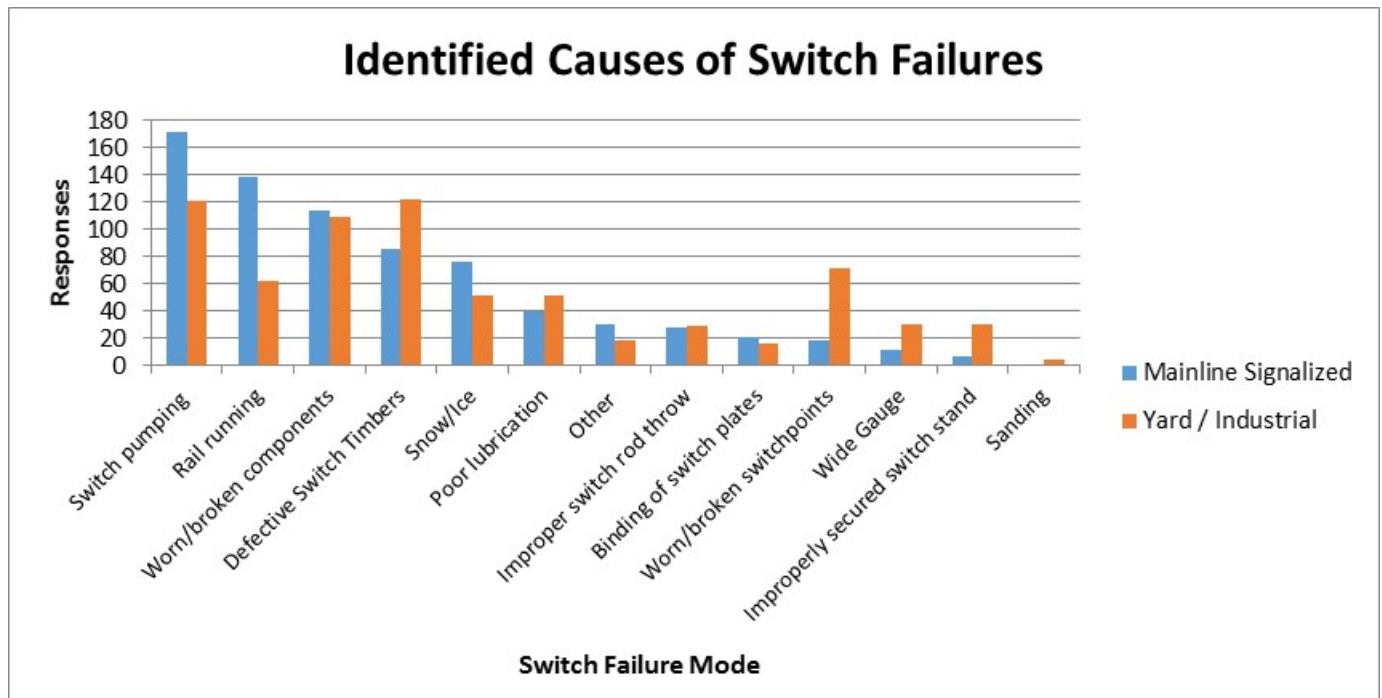
Figure 1 shows a plot of the responses received from five Class I railroads. The responses for the questions on top switch failure causes were used by TTCI to identify the top five causes of switch failures for mainline and yard/industrial categories: switch pumping, rail running, worn and broken components, defective switch timbers, and extreme weather conditions—snow/ice.

Figure 1. Causes of Switch Failures from Survey of Six Class I Railroads
