Member-Level Redundancy for Steel Bridge Girders

Anna M. Rakoczy, Ph.D. and Duane Otter, Ph.D., P.E.

Summary

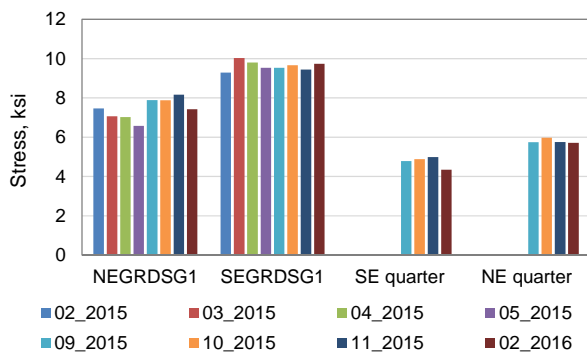
Figure 7. Mid-Span and Quarter Location Stress Comparison of North and South Girder, Train Speed 40 mph

The stresses near the center of the bottom cover plate at mid-span are remaining at the same level since February 2015 (Figure 7).

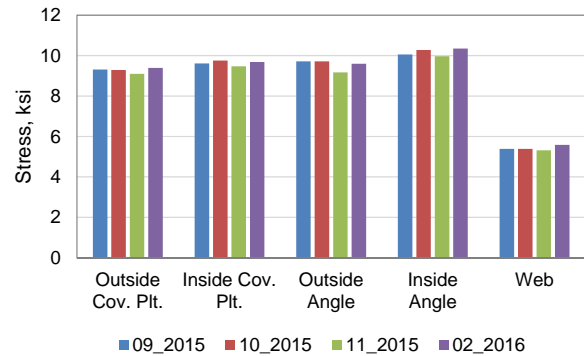
Figure 8. Stress Comparison of Various Locations on South Girder, Train Speed 40 mph

Figure 8 shows stresses on the south girder since September 2015, and they also are at the same level since the defects were introduced. The bridge will continue to be monitored, inspected frequently, and evaluated for repair should crack growth or a fracture occur.
