## Continued Performance of a High-Angle Crossing Diamond at FAST

### Part 1: Frog Bolts

Rafael Jimenez, Stephen Wilk, Kerry Jones, and David Davis

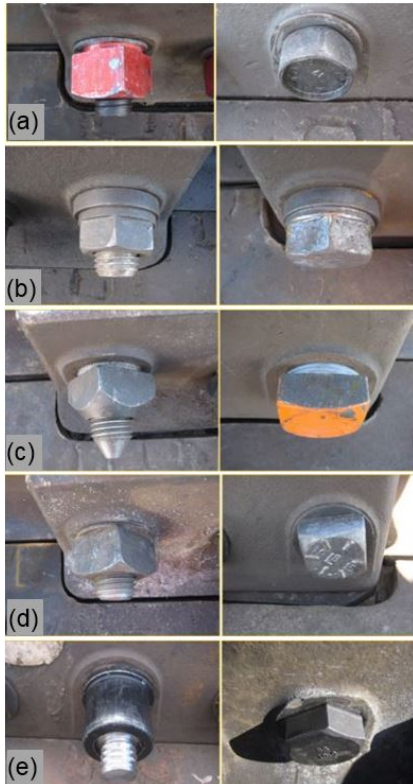
Figure 3. (a) NW Corner – Huck 360 Threaded Bolt; (b) NE Corner – Lewis Bolt & Nut (LB&N) Self-Centering Threaded Bolt; (c) SW Corner – Copper State Threaded Bolt; (d) SE Corner (Phase I) – LB&N Standard Threaded Bolt; (e) SE Corner (Phase II) – Huck Bobtail Lock Bolt.
