Continued Performance of a High-Angle Crossing Diamond at FAST

Part 2: Casting and Rail Components

Rafael Jimenez, Stephen Wilk, Kerry Jones, and David Davis

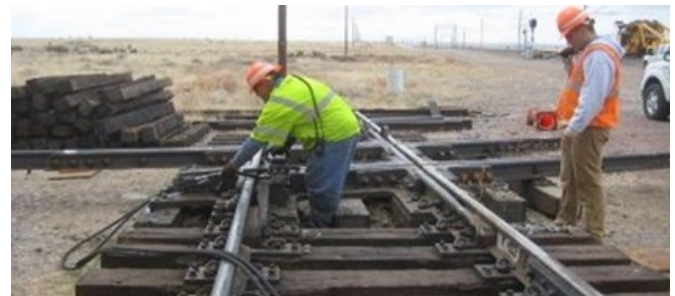
Out of track, the crossing was disassembled for a detailed inspection of components and documentation of conditions, as shown in Figure 2.

Figure 2. Crossing diamond being disassembled out of track for detailed inspection of components
