# Stabilization of Ballast Pockets with Geogrid in a Railway Embankment

Colin Basye and David Linkowski

## Summary

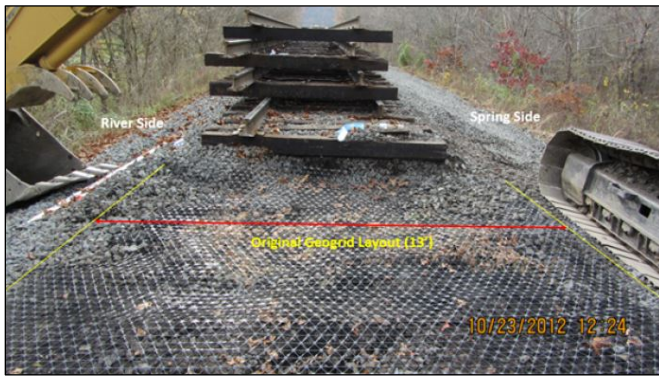
The geogrid was located 12 inches below the bottom of the ties during installation to allow ballast maintenance, provide stiffened support for the upper ballast section, and mitigate downward ballast migration into the ballast pocket areas.

Figure 4: TX190L geogrid was symmetrically located under the ties during installation
