Settlement of Fine-Contaminated Ballast

Stephen Wilk, Colin Basye, and Yin Gao

This *Technology Digest* is second in a series of an ongoing study investigating the behavior of fine-contaminated ballast when exposed to moisture. The project was conducted by TTCI under the AAR Strategic Research Initiatives Program, with joint funding from the Federal Railroad Administration.

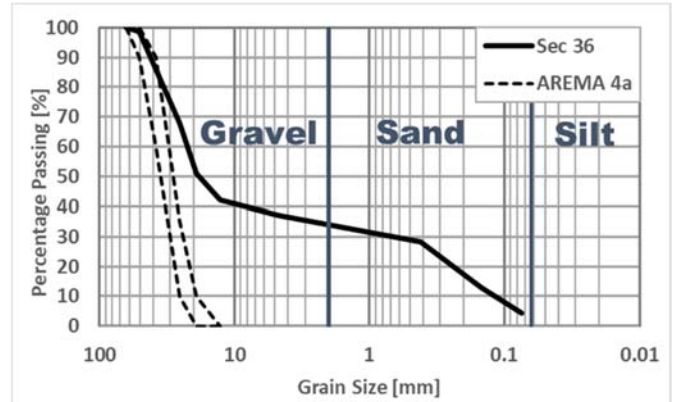
Figure 1. Grain Size Distribution for Rainy Section Ballast

The Rainy Section consists of 600 MGT degraded ballast granite, and has added fines passing the No. 4 sieve (4.76 mm) to 37.2 percent and the No. 200 sieve (0.074 mm) to 4.5 percent. This results in a Fouling Index (FI)¹ of 41.7 (37.2 + 4.5). The fine particles are generally sand-sized and non-plastic silt-sized and the result of granitic ballast degradation with minor eolian (windblown) sand, so they represent a naturally degraded granite ballast section. A grain-size distribution is presented in Figure 1.

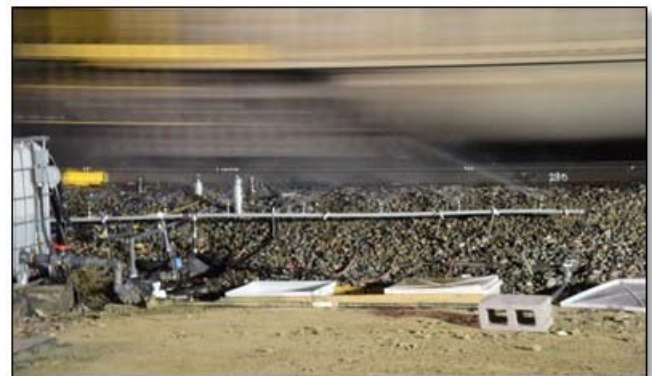
Figure 2. Water System during Train Passage

The first round of testing in the fall of 2017 focused on gradually increasing the number of train passes to ensure the settlement could be controlled and predicted. Therefore, the testing involved wetting the section during the last few train passes of each night, letting the section drain overnight, and then gradually increasing the number of train passes under wet conditions until an understanding of the behavior was obtained. Figure 2 is a photograph of a passing train during wetting.

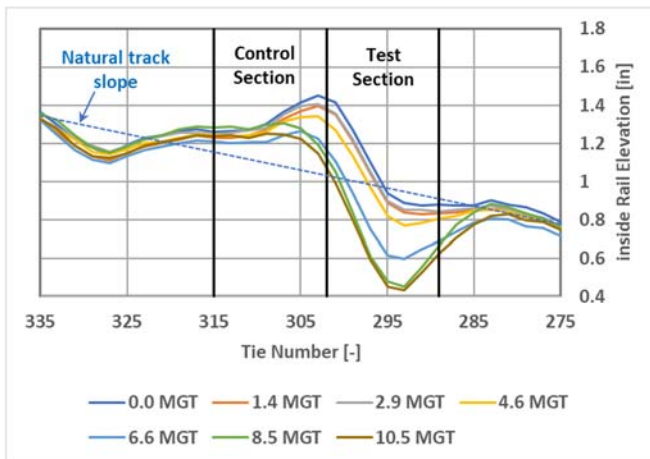
Figure 4. Rail Elevation with Distance

To measure the rail settlement during the course of the test, top-of-rail (TOR) surveys were taken after each night of FAST runs. The elevation and settlement over the course of test for the inside rail is displayed in Figure 4. The raw elevation data is displayed in Figure 4 and shows natural variation in vertical rail surface and gradual degradation of surface in the test section. Section 36 has a natural slope, explaining the elevation difference between both sides of the Rainy Section.

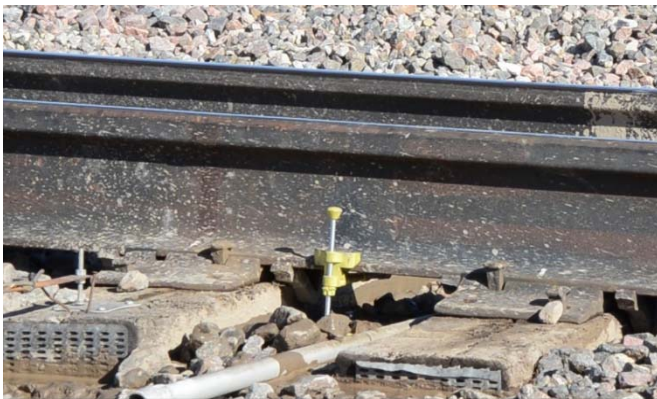
Figure 8. Photograph of Voidmeter

Dynamic measurements were taken with a Voidmeter (see Figure 8) to determine the maximum rail deflection during train passage. After the fifth night, a maximum rail deflection of 0.625 inch was observed. This correlates the loaded vertical surface deviation of ~0.75 inch to 0.875 inch and is below the 2-inch limit for Class 4 track, which is the design standard for FAST.
