Performance of Two Frog Weld Repair Techniques

Stephen Wilk, Benjamin Bakkum, David Davis, Duane Otter

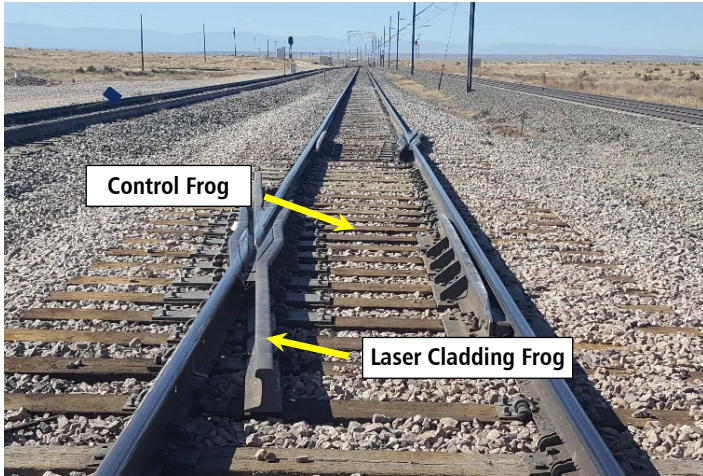
Both frogs are No. 10 and received no tonnage since weld repairs were made. To minimize effects from any vehicle dynamics caused by one frog on the other, the frogs were spaced at a half-car length apart (~31 feet) and were installed on opposite rails because the weld repairs were made on opposite wings. The frogs in Section 33 are shown in Figure 1.

Figure 1: Configuration of test frogs in track

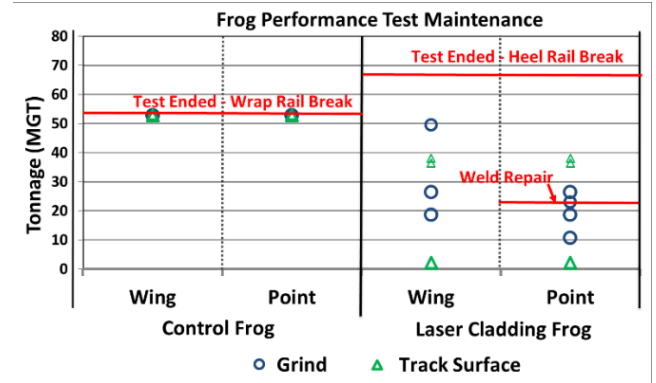
A maintenance log that includes grinding, surfacing, and repairs is shown in Figure 3. The 18.6 and 24.5 MGT grinds were suggested by the weld manufacturer and the railroad who supplied the two frogs.

Figure 3: Maintenance log of frogs

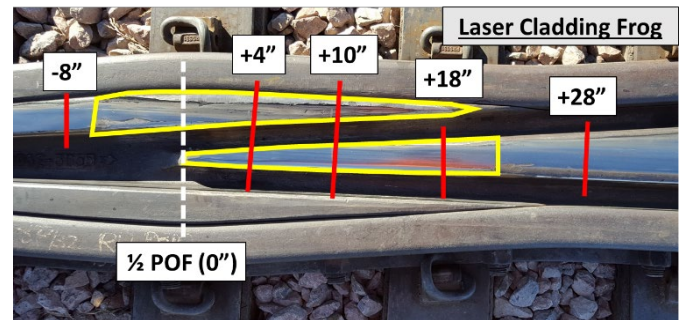
To measure the wear, the profiles of the point and wing were measured at specific locations and intervals. The analyzed locations for the control and test frogs are shown in Figures 4 and 5, respectively. The red lines are the profile measurement locations, the yellow shapes are the weld repair regions, and the white line is the half-point of frog (POF). The measurement locations allow the comparisons of the weld repairs at 4 and 10 inches from POF and weld repair against castings with the -8 and 28-inch measurements. The additional measurement at 18 inches on the test frog is to verify material behavior of the weld repair.

Figure 4: Locations of weld repairs and profile measurements from 5/8-inch point of the laser cladding frog

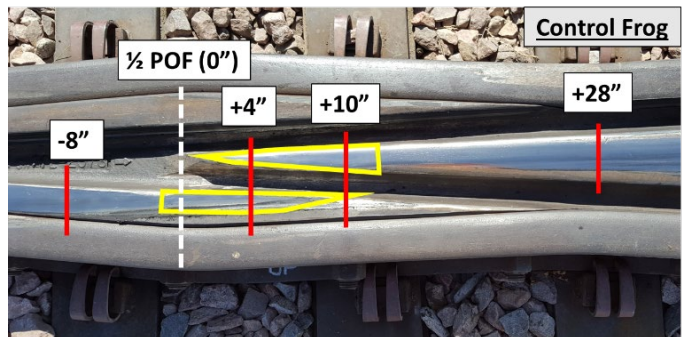
Figure 5: Locations of weld repairs and profile measurements from 5/8-inch point of the control frog
