## Assessment of Service-Worn, 110-ton M-976 Trucks

Alexander Keylin, Russell Walker, Chris Pinney, Tony Sultana, and Ryan Alishio

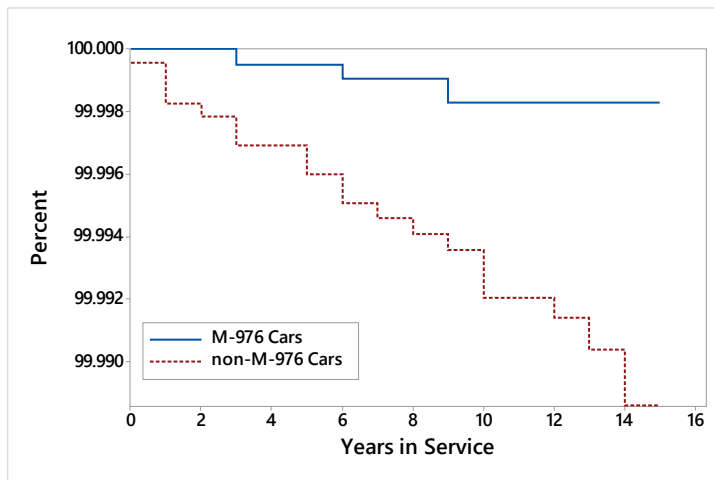
M-976 cars and four such derailments (two on main track, one on yard track, and one on industry track) involving M-976 cars. Improper truck rotation was the most common cause of truck-caused derailments in either group.

Figure 2 shows the survival plot of the two car populations (percentage of cars that have not derailed from truck-related causes as a function of their years in service). A right-censored non-parametric survival analysis of the data showed that amongst the cars built between 2003 and 2017, M-976 cars had lower rate of truck-caused derailments than non-M-976 cars, statistically significant at a 95% confidence level.

Figure 2. Survival plot for M-976 and non-M-976 cars built in 2003–2017

relatively young, the derailment statistics and their confidence intervals are very sensitive to the studied time interval. It is recommended that this statistical analysis is repeated in 3 to 5 years when M-976 railcars acquire longer time in service to further validate current results.
