Research described in this Technology Digest was performed by Transportation Technology Center, Inc., a wholly owned subsidiary of the Association of American Railroads.

Effectiveness of Corrective Grinding

Scott Cummings

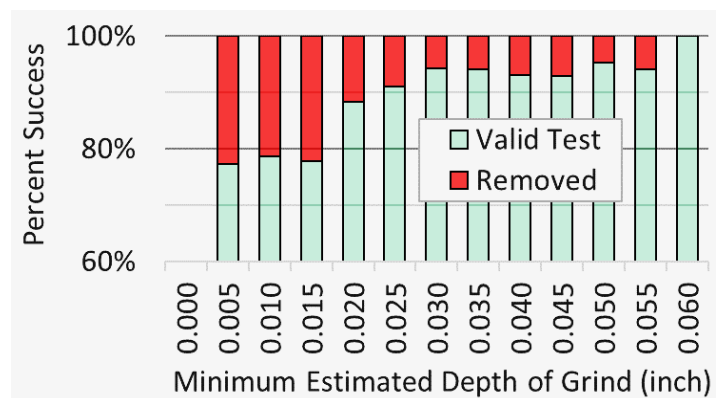
Figure 3. Success rates by grind depth

Figure 3 looks at the relationship between grind depth and outcome. For example, rail exceptions produced valid tests in 77 percent of the grinds that removed at least 0.005 inch of metal, 88 percent of the grinds that removed at least 0.020 inch of metal, and 100 percent of the grinds that removed at least 0.060 inch of metal.

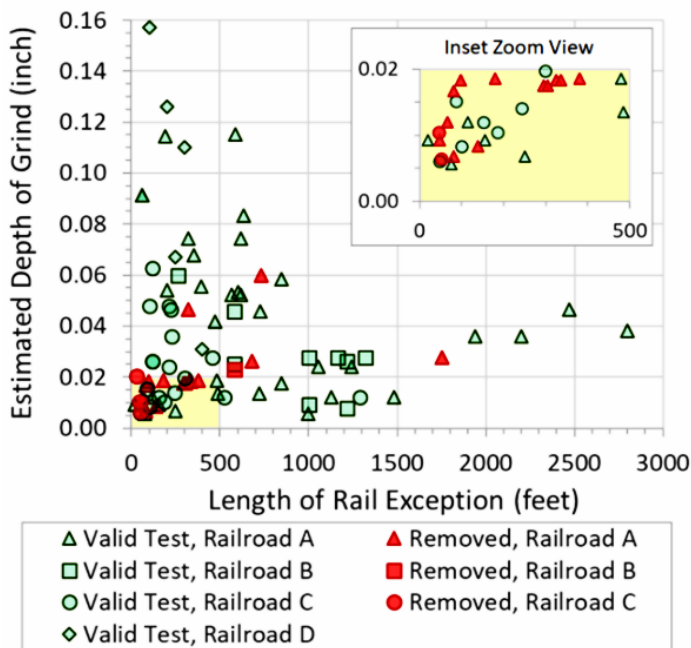
Figure 4. Grind depth and outcome as a function of rail exception length

Figure 4 shows the relationships between rail exception length, estimated grind depth, and post-grind results for four different railroads. One successfully ground rail exception is omitted from Figure 4 due to its length of 3.5 miles (18,480 feet).

Railroad A attempted corrective grinding on six rail exceptions of more than 1,400 feet in length, and five were successful. Deep grinds were successfully executed on each of the four railroads with 0.060 inch to 0.157 inch of rail removal. This type of deep corrective grinding opens the possibility that alternative supplemental technologies, such as rail milling, may have potential application for North American freight railroads.
