Update on Cold Weather Evaluation of Premium Rail Performance

Benjamin Bakkum, Richard Joy, Ananyo Banerjee, Dustin Clasby

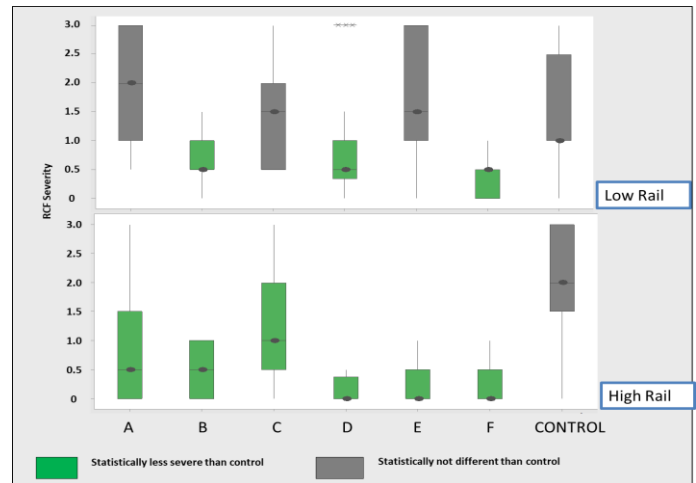
Figure 3. RCF severity for all rail types at 60 MGT

Following installation of the test rail strings, moderate to severe RCF developed throughout the test curve during accumulation of the first approximately 60 MGT. If not properly addressed, rail RCF can decrease the lifespan of rails significantly.

The team analyzed the RCF severity using a qualitative method of severity evaluation developed by TTCI.¹ This evaluation is judged on a scale from 0.0 to 3.0 with 0.0 representing no RCF development and 3.0 being severe RCF development. The results showed that all of the test rails developed less RCF, in general, than the control rail on the high rail of the curve. However, three vendor rail types developed more severe RCF than the control rail on the low side of the curve. Figure 3 shows the results of this analysis.²

Initial analysis indicated that a likely cause of RCF was improper gage face lubrication throughout the test curve. Following corrective grinding of both low and high rails and adjustments to the nearby lubricator units, inspections have shown only minor RCF development. Figures 4 and 5 illustrate the difference in RCF seen at the test site between initial and subsequent inspections.

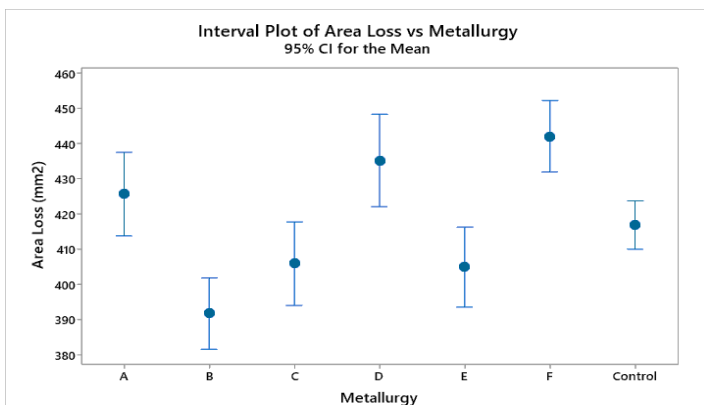
Figure 6. Low rail total area loss by vendor type

A post hoc test was conducted to compare the means to each other to determine which performed differently. Figures 6 and 7 show that rail types B, C, and E have the least rail wear overall.

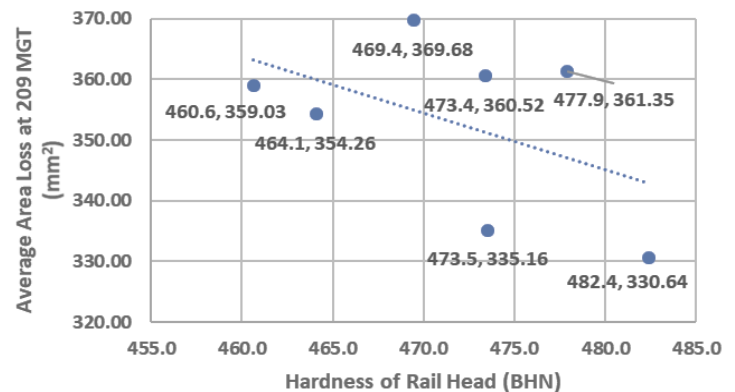
Figure 8. Brinell hardness versus average total area loss by rail type

Testing at the Facility for Accelerated Service Testing (FAST) near Pueblo, CO has shown that rail hardness is directly related to wear.³ The results for testing at the northern mega site (Figure 8) shows a similar trend—rails with higher hardnesses generally wear less. The data however does not appear to correlate fully with past findings as there are outliers where the inverse appears to be true; i.e., rails with higher hardness have actually worn more. Figure 8 shows average area loss which includes grinding loss and natural rail wear. The weak correlation between hardness and area loss is possibly because natural wear was not separated from total area loss as measurements were not collected immediately before and after grinding. At FAST, rail wear data is collected before and after grinding with no tonnage accumulation in between to separate natural rail wear from area loss from grinding.
