Revenue Service Test of a Robotically Welded Frog

Stephen Wilk, Duane Otter, Benjamin Bakkum, and David Davis (retired)

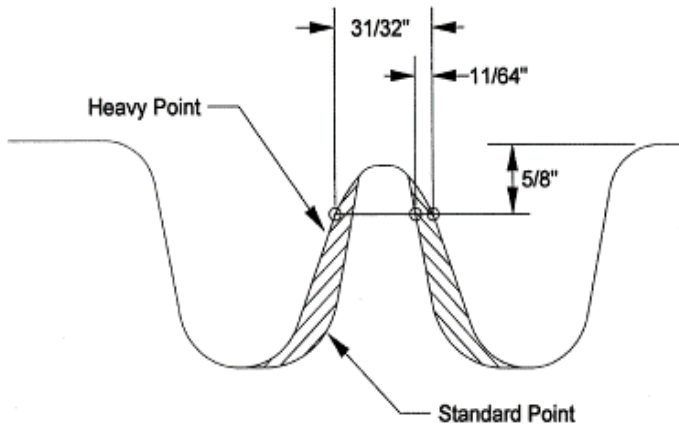
The repaired frog was built in 2013 as part of an AAR-sponsored industry evaluation of frog designs.¹ It was built initially as a heavy point frog with conformal (lateral profile) running surfaces. The heavy point design means the frog point is wider than the theoretical design over its first 4 feet. At the 5/8-inch point (the physical start of the frog point) it is 31/32 inch wide. Figure 1 is a cross section drawing of standard and heavy point frogs at the 5/8-inch point.

Figure 1. Heavy point frog cross-section

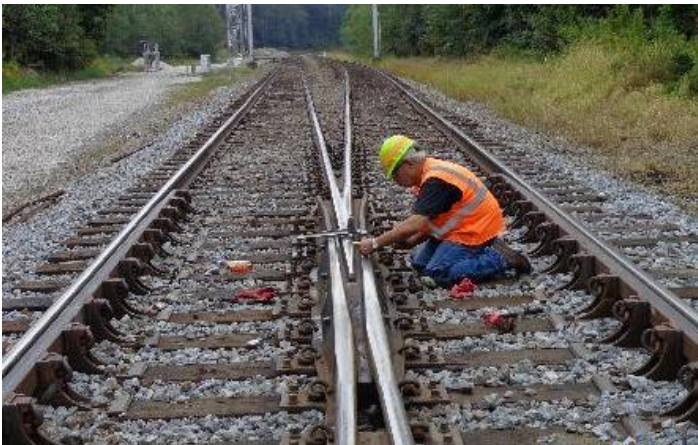
Figure 2 shows the original frog installed at Kings Mountain, Kentucky in 2013. Figure 3 shows the repaired frog at Corman, Kentucky, installed in late 2018.

Figure 2. Kings Mountain, KY test location
