EVALUATION OF A PROTOTYPE FLANGE BEARING FROG FOR HEAVY HAUL SERVICE

by David D. Davis, Don Guillen, and Joseph LoPresti

TTCI
Transportation
Technology Center, Inc.

August 1999®

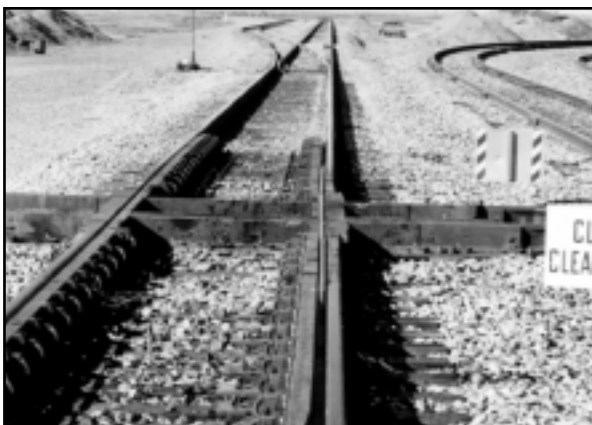
Exhibit 1. Nortrak 90 Degree FBF Diamond at FAST

The diamond consists of four large austenitic manganese steel (AMS) castings, or beams. Two beams in a half-lapped joint form each frog. In the tread bearing version, the casting ends are shaped like rails. Leg rails are flash butt welded to the castings to provide a jointless running surface on the mainline track.

In the flange bearing version, the joint detail remains the same for the tread rail. The flange bearing ramp rail is bolted to the tread rail and butt-jointed to the casting. Also, the castings were modified to provide a raised flangeway bottom and more support under the flangeway. Exhibit 1

shows the diamond as installed at FAST.
