## A Machine Vision System for Monitoring Railcar Health: Preliminary Results

by John M. Hart,\* Narendra Ahuja,\*  
Christopher P.L. Barkan\* and David D. Davis

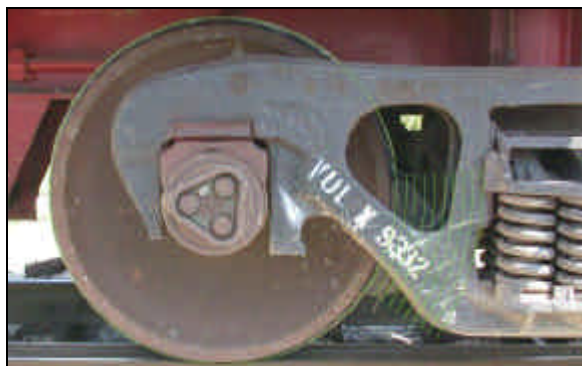
Figure 1. Brake Location Identified

Several algorithms have been developed that can identify the location of particular parts of a railcar truck. Figure 1 shows that the wheel of the truck has been identified and highlighted in the image. The algorithm has also identified the location of the brake shoe, which has been highlighted as well. This is the first step in the determination of the state of the brake (whether the brake is applied or not) and in the identification of the brake shoe itself. This will then allow the determination of the shoe thickness by calibrated measurement techniques. This thickness measure will be automatically compared to the minimum requirements for brake shoe thickness specified by the AAR (e.g., 1/2 inch for cast iron and 3/8 inch for composite shoes).

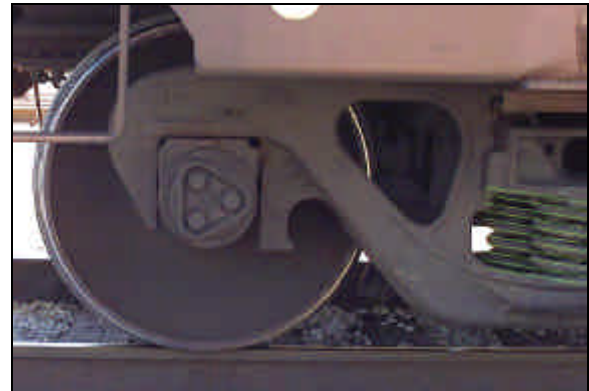
Figure 2. Spring Set Location Identified

Figure 2 depicts the identification of the location of the spring set and the springs highlighted by the algorithm. From these measurements, the algorithm will be able to determine if the springs are fully compressed. It should also be possible to determine if one of the front springs in the set is missing.
