Signal Shunting Performance Related to Application of Wayside Based Top of Rail Friction Control Materials

Richard Reiff and Kevin Conn (NS)

Summary

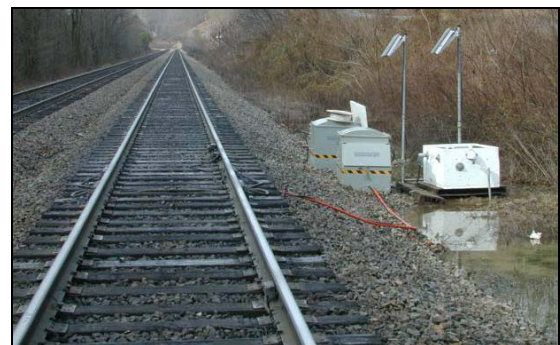
Figure 1. Signal Shunt Monitoring Site and Key Features

During the past year, NS has implemented 14 wayside-based TOR application systems over a section of double track east of Bluefield, West Virginia. Although each track is capable of and receives bi-directional traffic, most westbound traffic, which consists primarily of empty coal unit trains, is routed on Track 2. Studies have shown* that loss of shunt is more common with light axle loads where films can create a high resistance, or even destroy, the electrical path between the rail and wheel. Figure 1 is a view looking westward of the overall shunt monitoring site and key features.

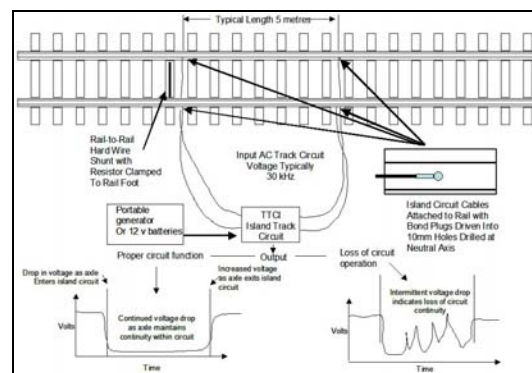
Figure 2: Schematic of Short Track Circuit

To determine the effect of TOR FM on shunting, a short track circuit was installed on Track 2 near mile post (MP) N357.9, Figure 2. This short circuit was 50 feet in length and was intended to capture the shunting characteristics of a single car or pair of trucks. The short length of this track circuit is understood to be worst case. A longer circuit would allow more axles to be present, thus reducing the effect, if any, of TOR FM films causing even intermittent loss of shunt.
