Automated Cracked Wheel Detection System Overview

Greg Garcia, Semih Kalay, and Daniel Carter

SUMMARY

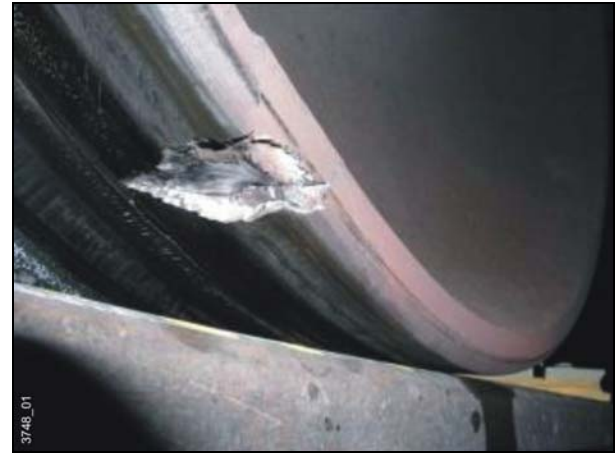
Figure 1. Shattered Rim Crack

Pattern recognition provides real-time assessment and reporting of flaw type, size, and location in and across the tread and rim of the wheel. Sensitivity has been focused toward detection of those shattered rim and tread cracks 0.5-inch long or greater. Figure 1 shows a shattered rim crack (SRC) that has broken open to the tread surface. The ACWD system is designed to detect flaws before they get to this point.

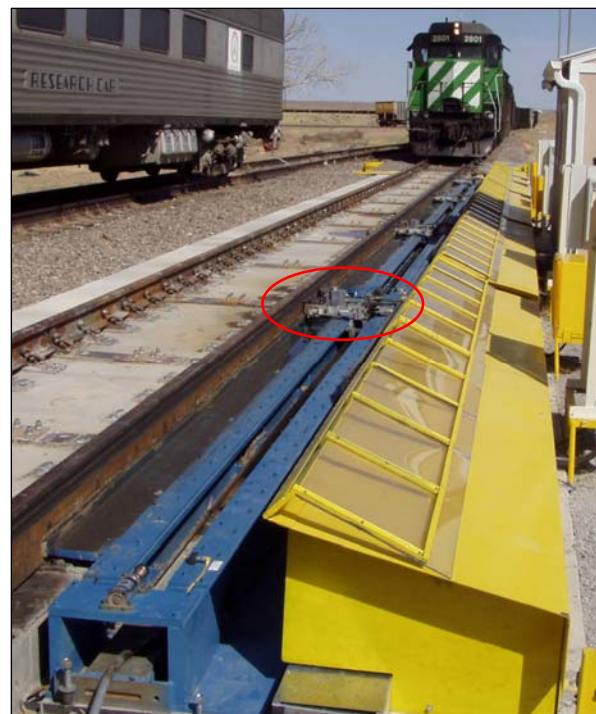
Figure 2. Inspection Heads

To provide access to the wheel tread, flange bearing rails were installed that allow the inspection heads to remain in full contact with wheel treads as the train passes through the test station. Figure 2 shows the inspection heads that have been designed to track each wheel tread vertically, laterally, and longitudinally using rotary trim sensors at each test station. The inspection heads have a spring suspension on each end to allow for continuous inspection, whether the inspection head is on a leading or trailing position with respect to the wheel. The length of each test station has also been designed to accommodate the inspection of railroad wheels up to 42 inches in diameter.

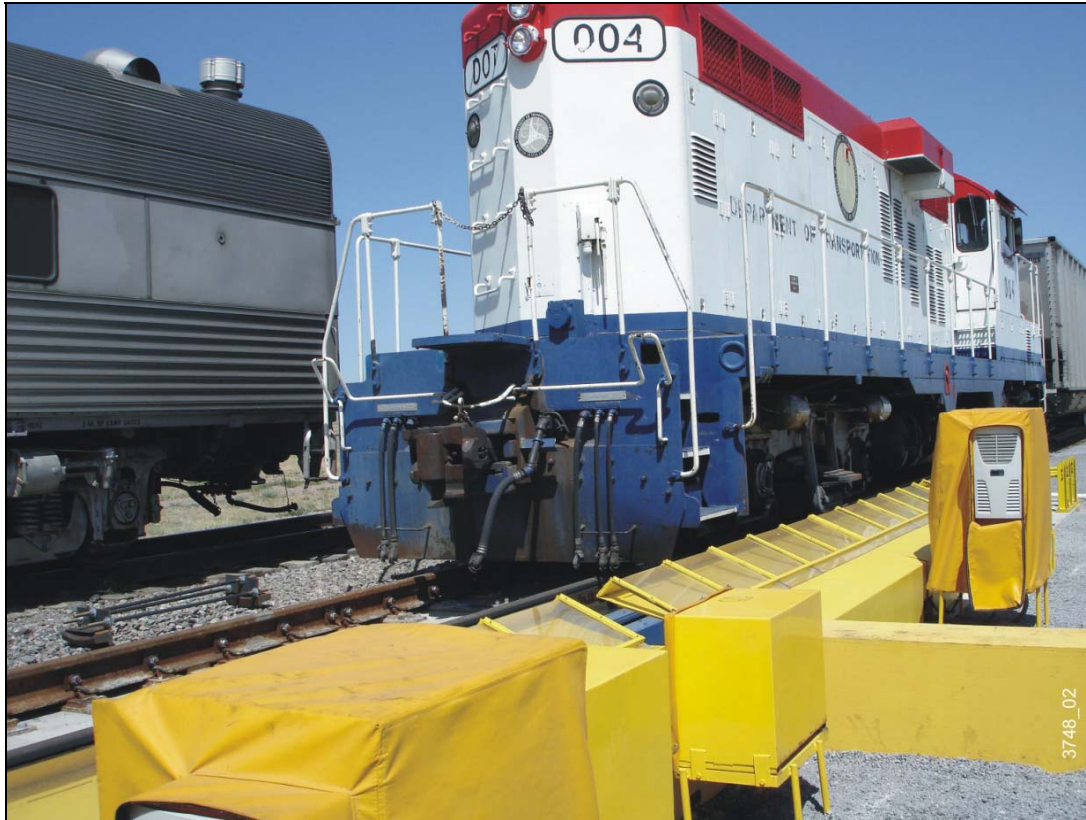
Figure 3. Train over the ACWD Test Site

There have been several trains inspected through the ACWD system: (1) a 13-car TTCI test train, (2) a 64-car heavy axle load (HAL) (315,000-pound cars) train that operates at the Facility for Accelerated Service Testing (FAST), and (3) a 105-car Union Pacific (UP) unit train (empty 286,000-pound cars). Figure 3 shows a test train proceeding through the system.

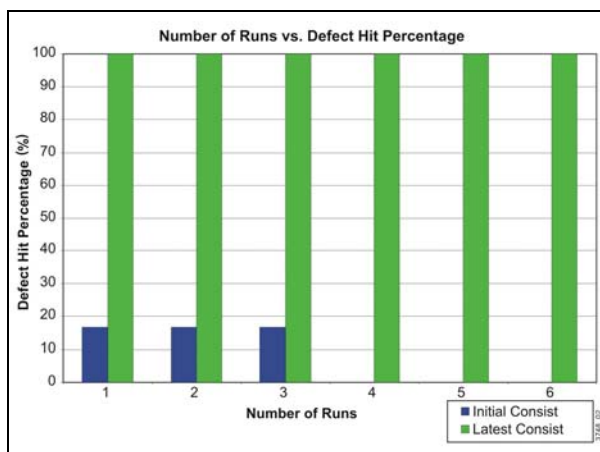
Figure 4. Repeatability Comparison

After the modifications to the ACWD system were made, a calibration wheel containing 0.25-, 0.50-, and 1-inch flat bottom holes (FBH) was added to the test train to determine the system's repeatability. Several test runs were made, and all three FBHs were detected during each run. The pattern recognition system was also able to distinguish between the sizes of the FBHs by observing the number of ultrasonic hits (counts) across each of the artificial flaws. Figure 4 shows the improvement in repeatability from a comparison of runs made during initial testing performed in March 2006, and the qualification testing performed in August 2006.
