Rail-Wire Interface Performance Issues

David Read, *Michael House, and David Davis

Summary

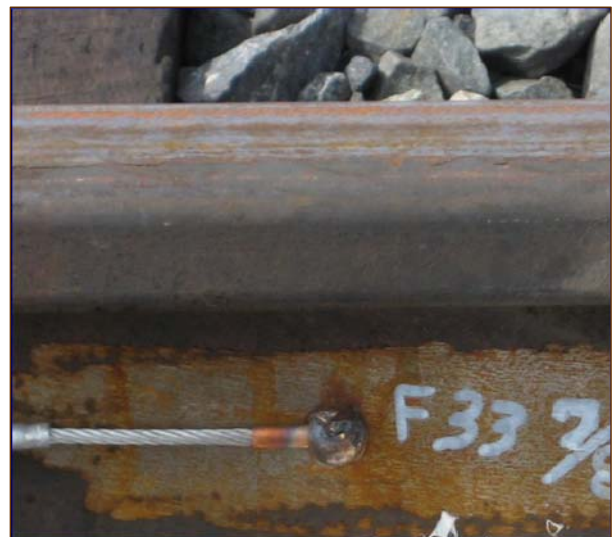
Figure 1. Exothermic RWI

- exothermic welds (Figure 1), factory installed pin-brazing on prefabricated insulated joint plug rails, and
- field installed pin-brazing (Figure 2).

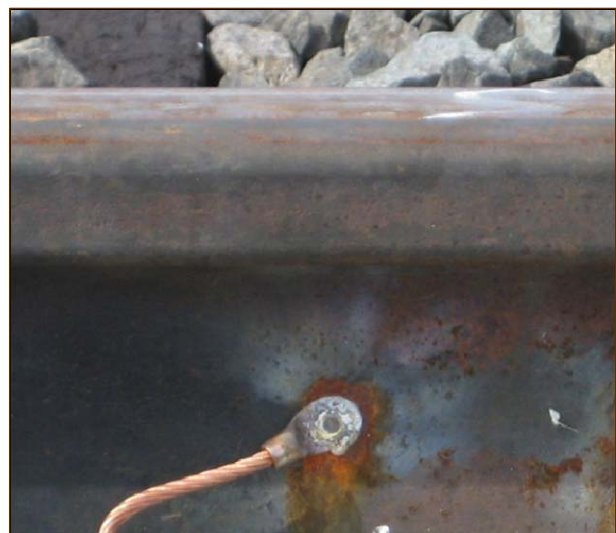
Figure 2. Pin-Brazed RWI

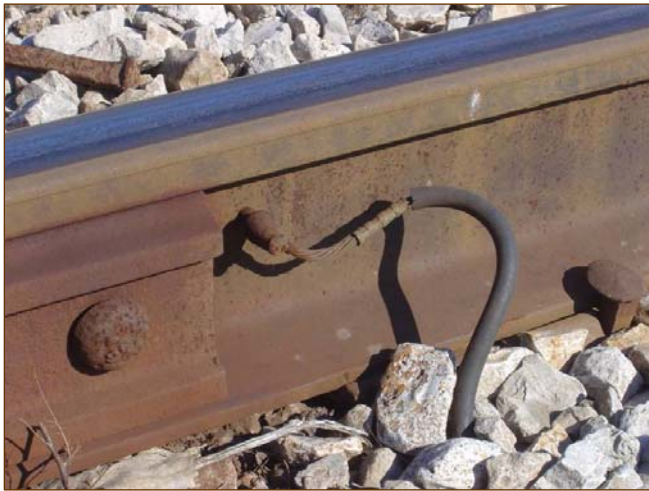
Figure 3. Tapered Pin RWI (i.e., Chicken Head)

The limited use of mechanical tapered-pin plug bonds known as “chicken heads” (Figure 3) for specific applications where flammable materials were handled, such as signaled sidings, where locomotives are fueled and customer facilities handling flammable cargo, such as solvents and propane, was also mentioned. Chicken heads require the rail to be drilled and are no longer commonly used by most railroads.
