Automated Safety Appliance Inspection System Evaluation

James Robeda and Semih Kalay

Summary

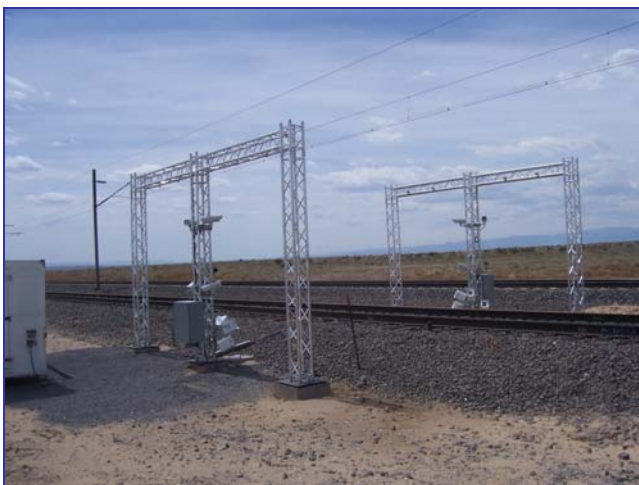
Figure 1. Vendor A Installation at FAST

In 2006, under the direction of the AAR’s SRI Technology Driven Train Inspection (TDTI), the University Illinois at Urbana-Champaign conducted a proof-of-concept demonstration verifying the feasibility of machine vision technology for this application. The successful completion of this demonstration and the increasing use of machine vision technology in the railway industry prompted further development of a prototype system. In 2007, a request for proposal was issued to develop a prototype system to assess safety appliance condition on open top hopper and high sided gondola cars with the capability to incorporate additional car types in the future. Two vendors were chosen to develop prototype systems (Figures 1 and 2) to be installed and tested at the Facility for Accelerated Service Testing (FAST), Pueblo, Colorado. Initial testing and evaluation was completed in October 2008.

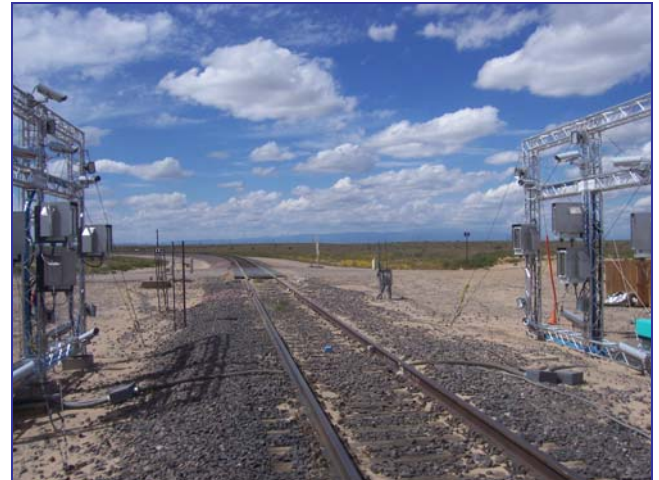
Figure 2. Vendor B Installation at FAST

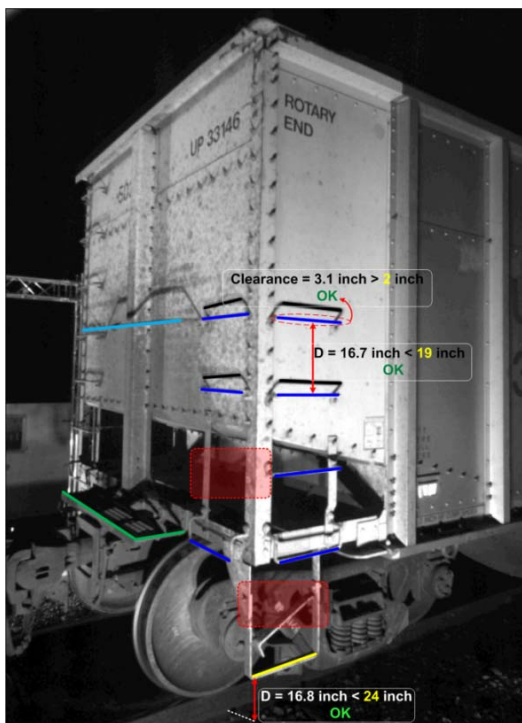
Figure 3. Vendor A Processed Image

Vendor A’s system was tested on June 30, 2008. The test consist was made up of 50 cars with 4-test cars having five known defects. The train made five passes in each direction at speeds of 15, 25, and 35 mph for a total of 30 passes. This equates to a total of 150-detection events. The system correctly identified 149 of these events for a successful detection rate of 99.3 percent. However, the system also reported high false-positive rates.

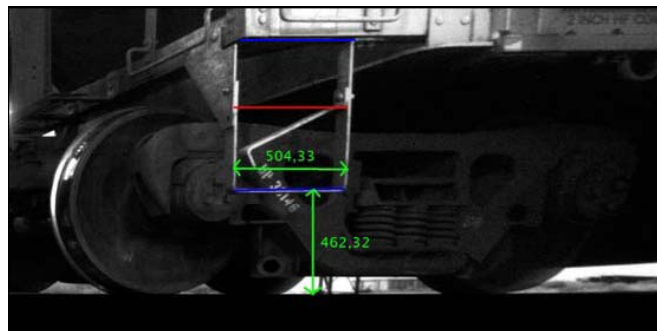
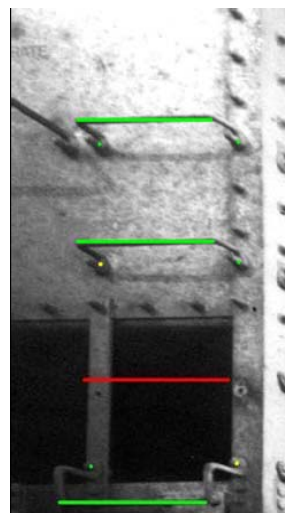
Figure 4. Vendor B Processed Images

Vendor B’s system was tested October 13, 2008. The test consist was made up of 50 cars with 5 having six known defects. The train made passes in each direction at speeds of 15, 25, and 35 mph for a total of 28 passes. This equates to a total of 168-detection events. The system correctly identified 166 of these events for a successful detection rate of 98.8 percent. However, the system also reported high false-positive rates.

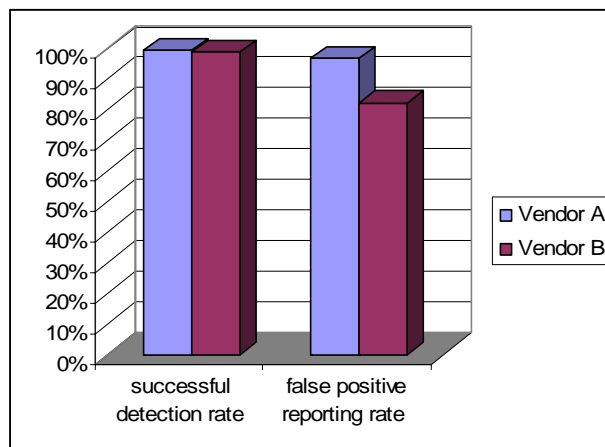
Figure 5. Test Results

The majority of the false-positive reports were triggered because the system failed to detect a safety appliance on the coal cars and reported it as missing. This occurred for handholds, ladder irons, and uncoupling levers. There were also a smaller number of false positives generated for clearance infractions, because thresholds were improperly set or reported measurements were not properly rounded.
