Railhead Repair Weld Residual Stress Investigation

Summary

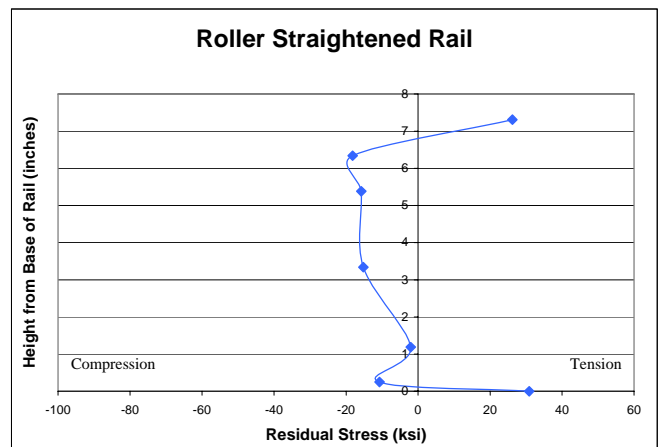
Figure 2. Longitudinal Residual Stress Profile for New Rail

The longitudinal residual stress profile for the new rail was primarily in compression with the exception of the top of the head and the base of the rail, which were both in tension. Contrary to the residual stress profile of the rail, both the thermite welds and the electric flash-butt plant weld had residual stress profiles in which the web was in tension and both the head and base of the welds were in compression. The stress profiles for the welds from the two different manufacturers were similar to each other, varying on average

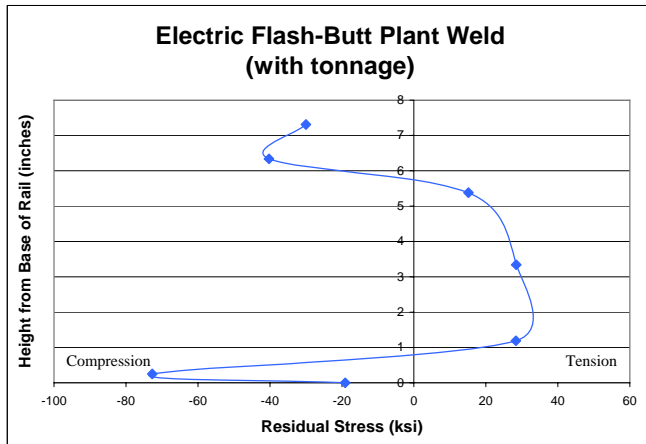
Figure 4. Longitudinal Residual Stress Profile for an Electric Flash-butt Plant Weld with Service Experience

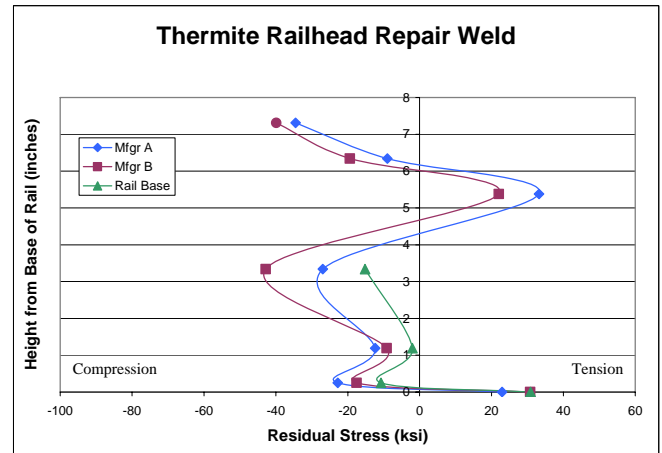
Figure 5 shows the residual stress profiles for thermite railhead repair welds made on rail for two different manufacturers. The residual stress patterns in the base of the rail below the thermite railhead repair welds were similar to that of roller straightened rail with the exception that they were shifted further into or toward compression by approximately 8 to 12 ksi. The measurements in the head region were similar to standard thermite welds, with the exception that the tensile stresses immediately under the railhead ranged from 1.2 to 2 times the residual stresses values under the railhead in standard thermite welds. This is important because railhead repair weld fatigue failures at FAST have initiated under the railhead at regions of cold lapping¹ that acted as stress concentrators. Consequently, care should be taken during weld installation to prevent cold lapping under the railhead, especially in the region of increased tensile stress.

Figure 5. Longitudinal Residual Stress Profiles for Thermite Railhead Repair Welds. The lower four points of a rail base profile are included for comparison (see Figure 2).

The residual stress profiles in the rail below thermite railhead repair welds were similar to the profile of the parent rail except that the stress profiles under the railhead repair welds were shifted from 8 to 12 ksi further into compression.
