# Ballast Degradation Test at FAST

Colin Basye, Dingqing Li, and David Read

## Summary

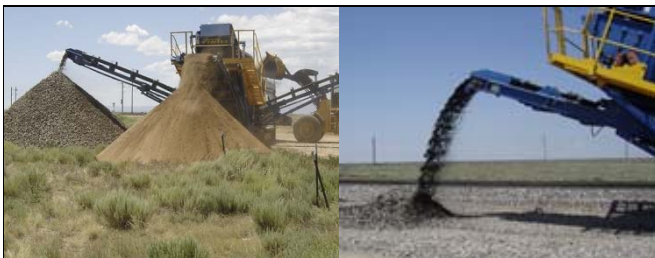
Figure 1. Construction of the Test Zone Ballast Blends

From 2009–2013, TTCI performed an evaluation of the effects of dust infiltration on track stability on the HTL. The introduction of clean, 15 percent, and 25 percent (of total voids) fines into the ballast mass was done in order to observe and compare track instability, lubricating effects of water, and dynamic effects on ballast mass. The various test sections were produced by blending each proportion after the materials were separated out from undercutter fines (Figure 1) obtained from revenue service sources.

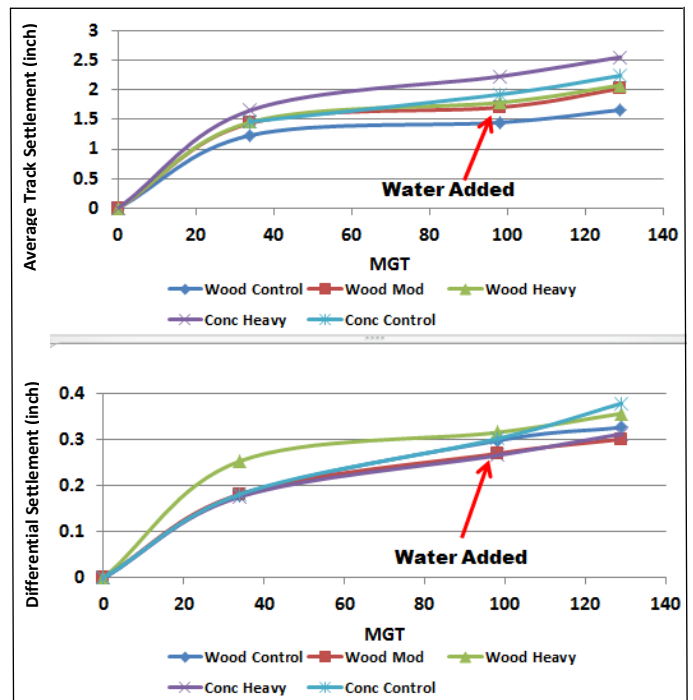
Track optical surveys were performed every 10 MGT on Section 36. As Figure 6 shows, average track settlement was significant up to approximately 30 MGT, with about 1.25 inches of settlement. After 30 MGT, the track stabilized considerably, with an average of approximately 1 additional inch of settlement for the next 170 MGT.

Differential settlement over time was also recorded, as Figure 6 shows, but it did not indicate a cause for additional scrutiny since differential variation was minimal between the various test configurations.

Figure 6. Average 2012 Track Settlement and Differential Settlement

Approximately 0.5 to 1.0 inch of water was added weekly to the test track sections during various phases of the testing. It was observed that hydration of the ballast and subgrade had slight effect on the settlement or stability of the subgrade in these test sections.

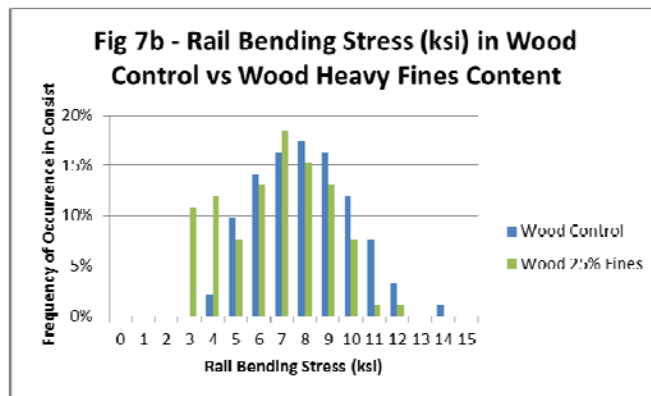
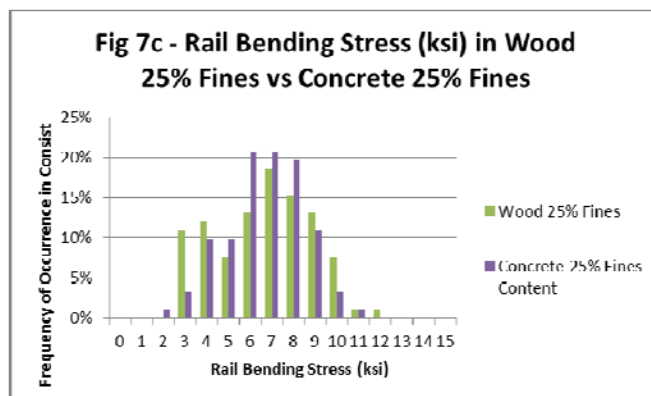
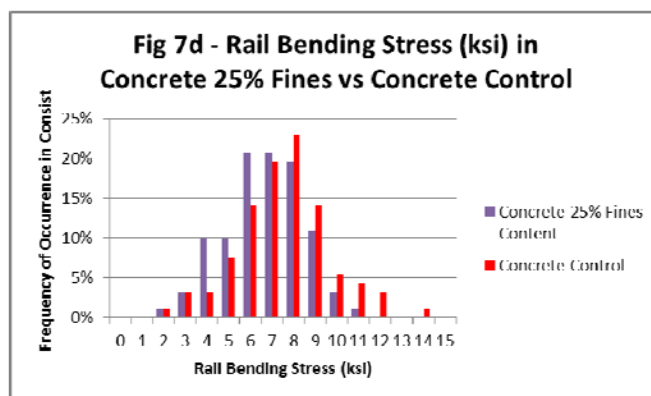
Figure 7. Rail Bending Stress During Consist Passage

Figure 7 shows comparisons that indicate rail bending stress was not significantly different between wood tie and concrete tie sections. Figure 7a shows average rail bending stress was 8 ksi, about the same in concrete tie sections as in wood tie sections, although concrete tie data was more tightly grouped. Results lead to the tentative conclusion that concrete ties offer slightly less variability in support, compared to wood ties.

Figure 7b shows the wood tie section with 25 percent heavy fines versus control measurements does not indicate a stress difference great enough to offer conclusive results.

Figure 7c shows average rail bending stress was almost identical in wood tie versus concrete tie sections with 25 percent fines, although the concrete ties offered a slightly more tightly grouped data set, possibly indicating less variation in concrete tie structural variability.

Figure 7d shows rail bending stress in the concrete tie control versus 25 percent fines had nearly identical peak occurrence and stress maximums, although the control data was grouped more tightly, possibly indicating less variation in control support variability.

Some of the results shown in the plots may be due to the fact that subsequent gradations revealed that the controls had more fines and the test sections had fewer fines than assumed when the measurements were made. In each testing event 2011 and 2012, similar results were observed, and no apparent correlation could be established.
