Investigating the Use of Flash Infrared Thermography for Cracked Axle Detection

Summary

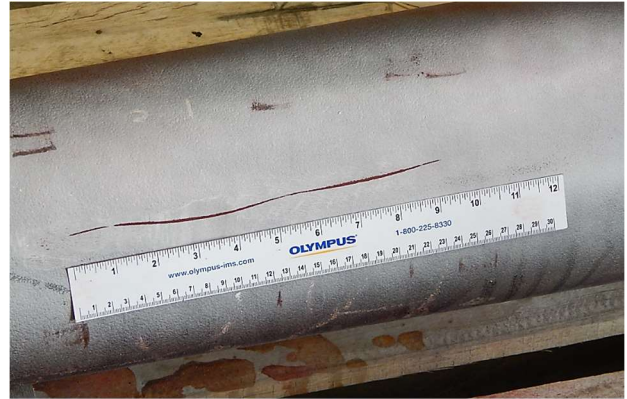
TTCI provided two cracked axle specimens from revenue service. Figure 1 shows the first axle with a longitudinal crack. This crack is about 10 inches long and about 1/2 inch deep.

Figure 1. Axle with longitudinal crack with contrast enhanced using magnetic particle testing.

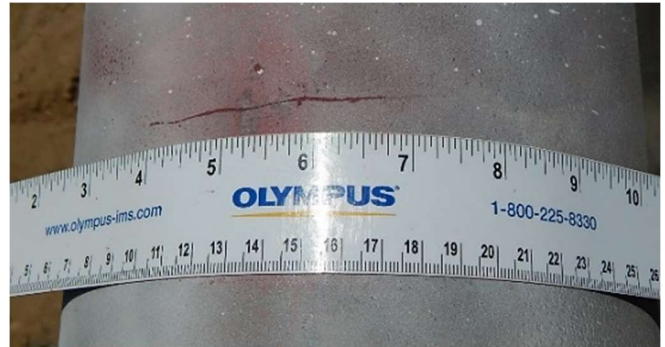
Figure 2 shows the second cracked axle specimen that has transverse (radial) cracks near the wheel seat. These cracks vary in size, the longest being approximately 3.5 inches long.

Figure 2. Axle with transverse cracks with contrast enhanced using magnetic particle testing.

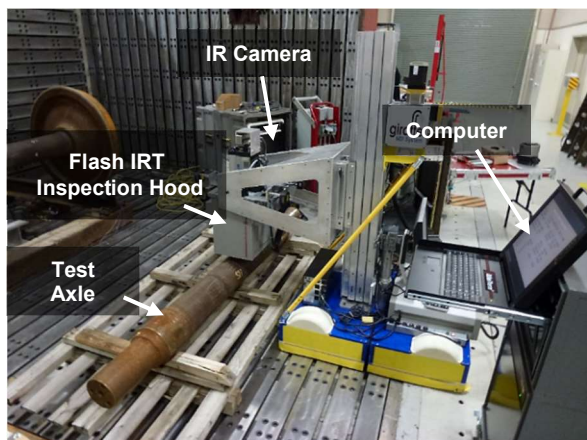
The experimental IRT setup that was used to inspect the rail axle in the laboratory is shown in Figure 3. In this setup, the inspection head was positioned upright to view the region of interest, a short duration heat flux was applied to the surface of the axle, and the IR camera recorded the thermal response of the same surface.

The inspection head includes a cooled IR camera and two xenon flash lamps. The enclosure around the camera and flash lamps acts as a kind of simple thermal lens that directs the energy forward toward the inspection area. It also serves as a safety shield, protecting bystanders from the heat source. A computer-controlled trigger of the flash lamps discharges the energy spike while the IR camera captures images of the structure before and after the flash discharge. The resulting images are continuously recorded by the computer.

Figure 3. Transient IRT system laboratory test setup

A pre-selected time or time range of IR images of the thermal response can be saved and analyzed using various image processing techniques. The team found that the IRT image collected within about 1 millisecond after the flash was most suitable for crack imaging on the steel axles. The above shown system was used to generate the flash pulses, IR images, and analyze the results. Also, this system was used to position the inspection head, including distance and angle, for sensitivity assessment.

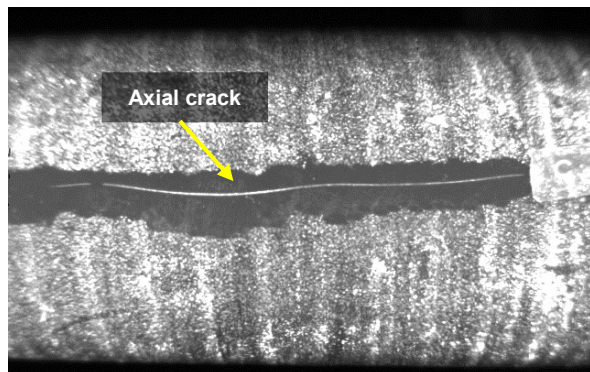
Figure 4 shows the flash IRT image taken of the axial crack.

Figure 4. Flash IRT image of the axial crack.

The IRT image was taken with the camera at a distance of 20 inches from the axle surface. The crack can be clearly seen. Even though the grinding mark (the result of an early attempt to remove the crack) enhances the contrast between the crack and the non-cracked area, the team is confident that it could still be automatically detected without the ground surface. General image analysis software and a specific crack detection algorithm developed by Boeing for x-ray backscatter imaging could be used to distinguish cracks from background noise.

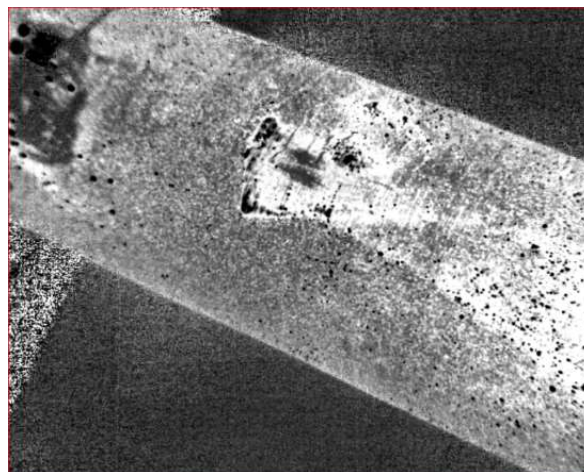
Figure 5 shows the flash IRT image of the axle with radial surface cracks. The crack is detectable by this method as are several adjacent small surface cracks or scratches. The NDE examination previously performed by TTCI on this crack indicates that it has shallow depth, and may not be much more than a deep scratch. Under these circumstances, the sensitivity is surprisingly good.

Figure 5. Flash IRT image of the radial crack.

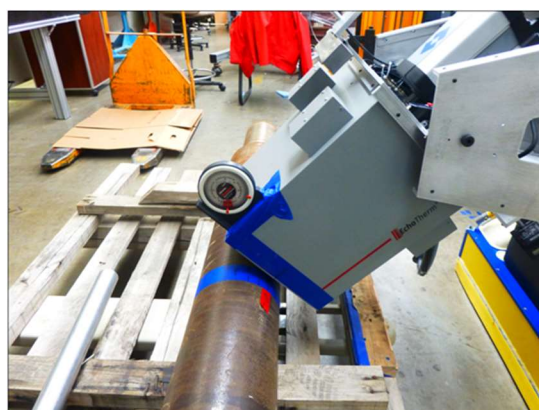
In order to estimate the number of images required for a complete inspection for an entire axle, several additional test were performed. The first test involved collecting IR images of the axial crack at different angles to determine sensitivity of crack detection to angle of rotation. Figure 6 shows the test setup. Blue tape was placed on the axle and angle markings were made on it so the angle could be seen in the IRT image. A device to measure the inspection angle was mounted to the inspection head.

Figure 6. Test set-up for crack angle sensitivity evaluation.

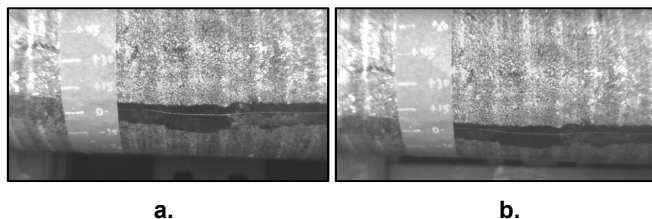
Figure 7 shows a set of results of the angle sensitivity tests. This result indicates that crack contrast drops off with rotation angle. This is due to a reduction in crack width relative to the camera, and also an increase in distance from

the camera due to the curvature. However, the crack is still detectable at a ± 45 -degree angle (though not detectable at $\pm 60^\circ$). Consequently, up to about 90 degrees of the axle could be covered in one IRT image, meaning four angles are required per axle. Smaller cracks may require a lower detection angle, so five angles may be prudent for full sensitivity.

Figure 7. Flash IRT images taken of axial crack area: a) 30°; b) 45°. Images taken at 20-inch stand-off distance

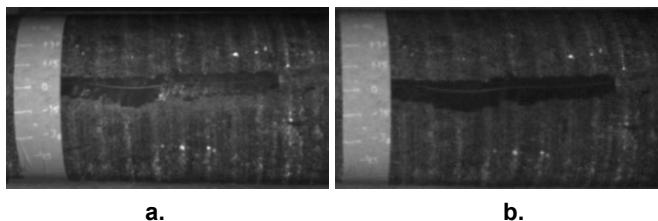
This determined the approximate number of angles needed but did not address how many cameras would be needed per angle. The team performed a simple sensitivity test on the axial crack with flash IRT at different distances. Figure 8 shows the results for two distances beyond the original 20 inches.

Figure 8. Flash IRT images taken at different stand-off distances from the axle: a) 36 inches; b) 48 inches

It is clear that distance from the axle has an effect on spatial resolution of the crack. However, even at more than twice the original distance (from 20 inches out to 48 inches), the crack is visible, even before any image analysis. This suggests possibly using a wide-angle lens on the IR camera at a reasonable distance from the axle to image an entire length with one camera.
