## Flash Infrared Thermography for In-motion Cracked Axle Detection

[Transportation Technology Center, Inc. \(TTCI\)](#), on behalf of the Association of American Railroads (AAR), is working with Boeing Research & Technology (BR&T), Seattle, WA, to develop an in-motion cracked axle detection technology based on flash infrared thermography (IRT) non-destructive evaluation (NDE). The Phase I work performed in 2017 by TTCI<sup>1</sup> established the feasibility of this NDE technology for the in-motion detection of axle defects on a moving train. This work also demonstrated good imaging capability for both longitudinal and radial surface cracks on the body of test axles in the laboratory environment. This *Technology Digest* summarizes the findings of the Phase II work performed in 2018 by TTCI in collaboration with BR&T. The primary objective of this research phase was to conduct a risk reduction effort. The goal was to eliminate the most relevant unknowns related to the application of flash IRT NDE method to moving axles. This work focused on determining and demonstrating flash IRT inspection capability on a moving axle. All work was performed at BR&T laboratories.

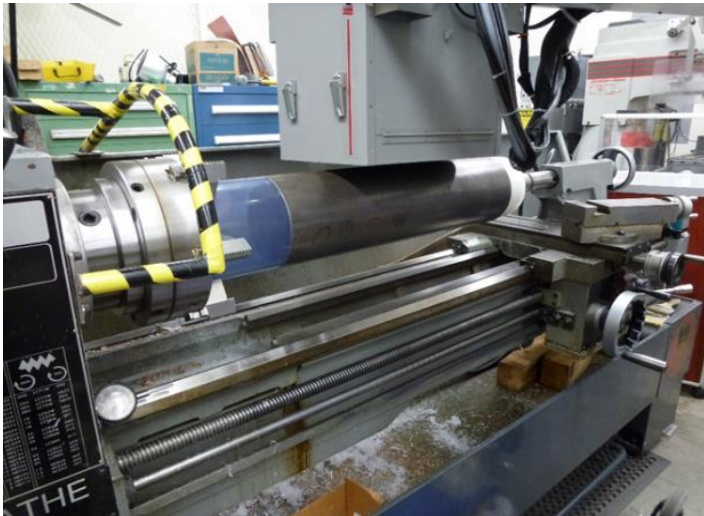
Figure 3. Flash IR hood over a test axle mounted on a lathe to spin at 200 rpm

that could be safely spun up to 15 mph equivalent speed. Figure 3 shows the test setup for the test axle mounted on a lathe, with the flash hood directed at it from above. The FLIR® camera aimed at the spinning axle would collect the images. The FLIR® camera used for this was the long wavelength high speed camera.
