Evaluation of In-Motion ECHO-Rail RCD Measurement System

Anish Poudel, Ph.D. and Matthew Witte, Ph.D.

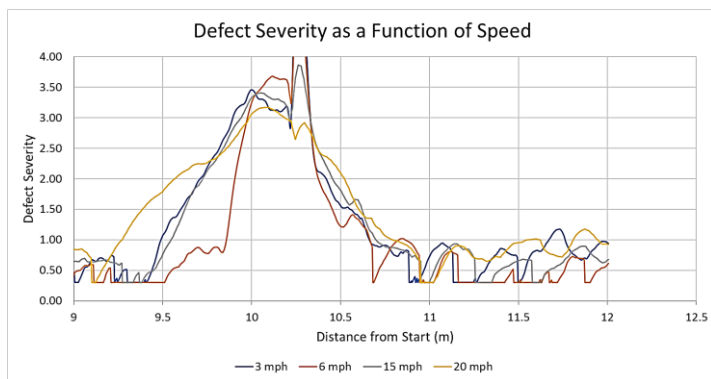
Section 3, High Rail Joint at 35 feet (10 m)

Figure 3 shows a typical ECHO-Rail defect severity measurement for the rail joint for different speeds. It is observed that the magnitude of the defect responses were consistent for all speeds. The onset of the initial defect response varies from 29.8 feet (9.1 m) for 20 mph to 32.1 feet (9.8 m) for the 6 mph run. This was due to the result of carriage instability as the rail joint was crossed. Significant jarring of the vehicle was noted as the vehicle crossed the joint.

Figure 3. Echo-Rail defect severity measurement for the rail joint

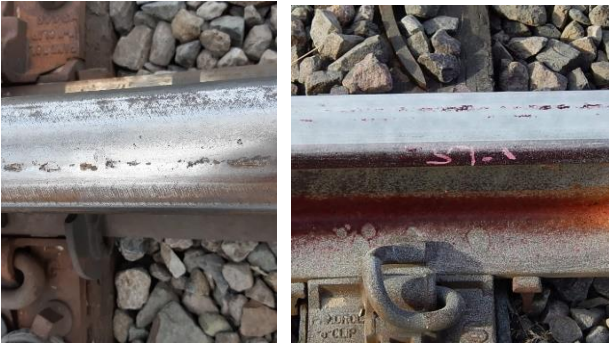
Figure 7. Visual and LPT test result for the low rail in HTL Section 3 at 57 feet location

Figure 6 shows the ECHO-Rail defect severity measurement for the low rail in HTL Section 3, 57 feet. RCD defect severity measurements were consistent for all speeds. Figure 7 shows the visual and liquid penetrant test result at that test location.

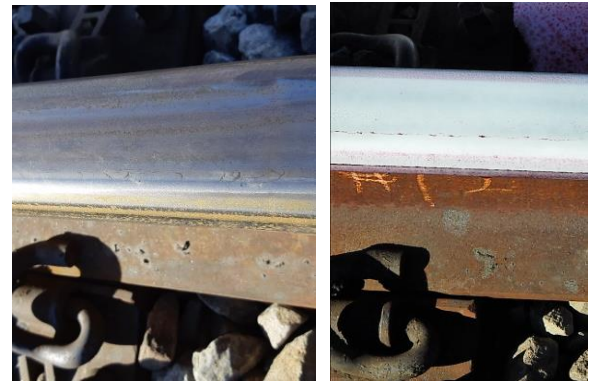
Figure 9. Visual and PT result for the high rail in HTL Section 7, 38 feet

Figure 8 shows the ECHO-Rail defect severity measurement for the high rail in HTL Section 7 at 38 feet. This location has a flash-butt weld and light RCD. The defect severity responses for the 3- and 6-mph tests and 15- and 20-mph tests were tightly grouped. The test vehicle was still accelerating for the higher speed tests of 15 mph and 20 mph. Significant jarring was present at this time, and the differences noted for the 15- and 20-mph runs may be related to the carriage instability. Results also indicate a jump in the defect severity value at the weld location. Dye penetrant and hand-UT analysis of this weld showed no defect present. Subsequent review suggested that the indication is primarily a function of the material property change associated with the weld. Further work will be required to optimize the analysis algorithm to compensate for the material change properties and process only the defect characteristics within the weld signature. Figure 9 shows the visual and liquid penetrant test result.
