### "Preliminary Analysis of Wood Tie Gage Widening Performance in a Heavy Axle Load Environment,"

TD 95-018

#### Summary

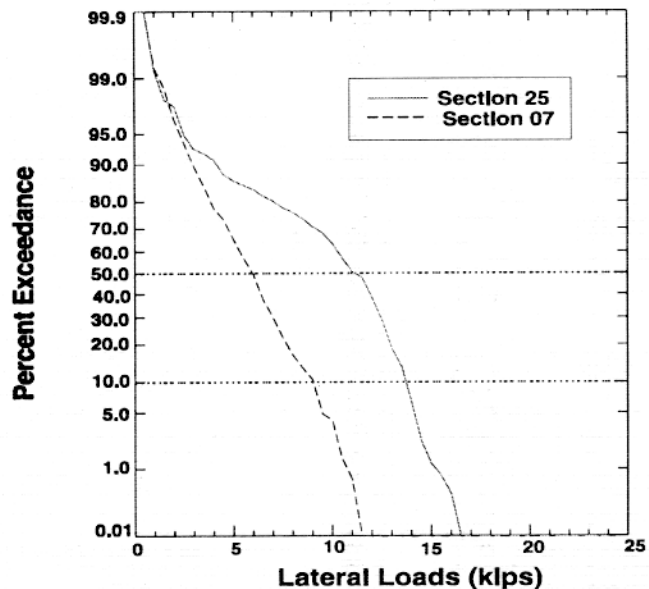
In spite of the numerous rail changes on the HTL, which required re-spiking, the lateral load environment appears to be the largest contributor to gage widening. Ties located in the higher lateral load environments were more susceptible to gage widening. Exhibit 1 shows a distribution of the lead axle lateral loads measured on two curves of the HTL. As shown, the lateral load environment for Section 25 is much higher

Exhibit 1. Distribution of Typical Lateral Load Environment on the HTL

than for Section 07. The increase is due to sharper curvature, differences in grinding profile, lubrication practices, and operating conditions on this section.

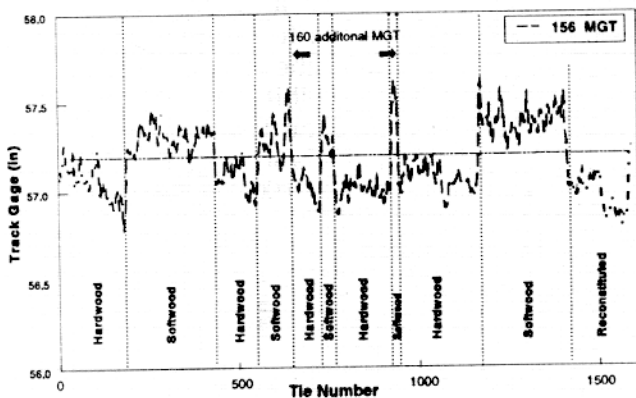
Exhibit 2 shows the widest track gage measured using the EM80 geometry throughout Section 25. The horizontal line shows that all of the softwood species have gage widened more rapidly than the hardwoods. The reconstituted ties at the end of the section did not gage widen as rapidly as the other ties installed at the same time. However, because of other failure modes, they were removed from track.

Exhibit 2. Widest Measured Track Gage In Section 25.

With an additional 160 MGT of HAL traffic, the Douglas fir and oak ties shown in the center of the exhibit show less or about the same gage widening as the other hard and softwood species. The Douglas fir in this section required re-gaging after 360 MGT of HAL traffic. However, the Douglas fir ties in

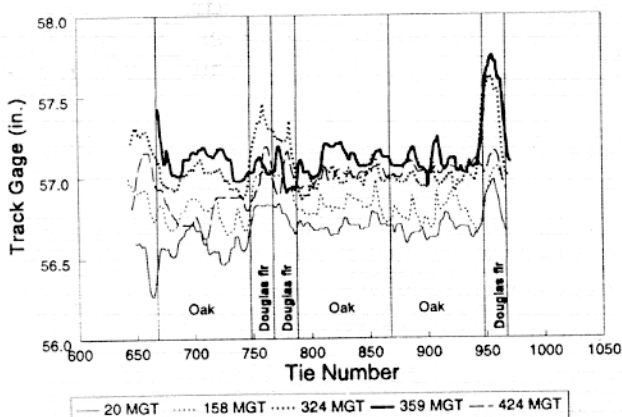
Exhibit 3. Gage In Section 25 - Douglas Fir and Oak Ties Test Areas.

Exhibit 3 shows track gage measured on the Douglas fir and oak ties only. The data shown reflects 424 MGT of accumulated HAL traffic. The two middle sections of Douglas fir ties, which are shown as a solid line on the plot, were re-gaged after 359 MGT of HAL traffic and retrofitted with Pandrol plates and coach screws. The Douglas fir tie section on the far right was re-gaged at 375 MGT and the cut spikes were retained. No change in gage widening between the two sections was noticeable at 424 MGT.

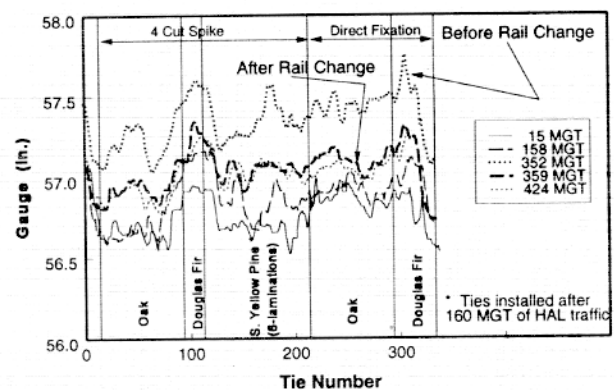
Exhibit 4 shows the measured track gage on the Douglas fir and oak ties in Section 07. The highest measured gage is about the same for both Sections 07 and 25, however, about 1/2 inch of the measured gage in Section 07 is due to rail wear. When comparing measurements at 352 and 359 MGT, the extent of rail wear in Section 07 is noticeable. The rail was changed just prior to the 359 MGT measurement. Because the installation of new

Exhibit 4. Gage In Section 07 - Douglas Fir and Oak Tie Test Areas.

rail was performed without re-gaging the plates, the measured track gage in both the cut spike and direct fixation fastening system zones can be attributed to long term degradation.

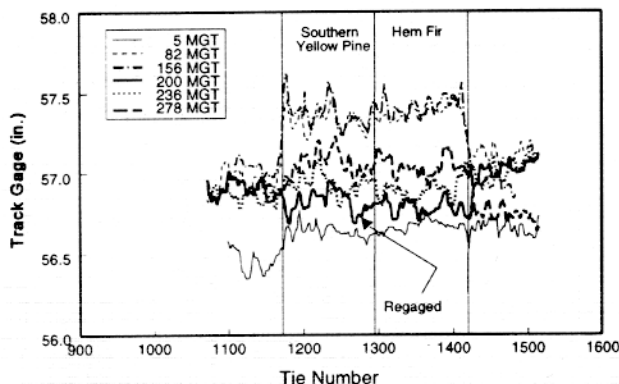
Exhibit 5 shows the measured track gage for the hem fir and Southern yellow pine. The change in track gage between 156 and 200 MGT of accumulated HAL traffic once again was due to re-gaging prior to the 200 MGT measurement.

**Exhibit 5. Accumulated Track Gage on the Southern Yellow Pine and Hem Fir Tie Test Sections.**

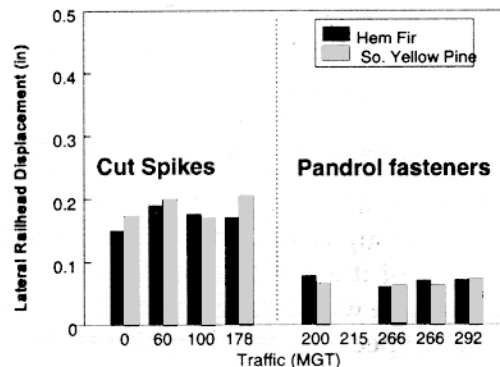
Track strength, a measurement used to monitor tie and fastener degradation, is determined by statically applying known vertical and lateral loads to the rails, while measuring the lateral railhead and rail base displacement. In Exhibit 6, railhead displacement measured on the hem fir and Southern yellow pine ties is shown. The data, under 40,000 vertical and 20,000 pounds static

**Exhibit 6. Lateral Railhead Displacement.**

loads, indicates that gage restraint increased after the installation of the Pandrol fastening system. The measured average lateral railhead displacement was about 50 percent less.
