ECONOMIC EVALUATION OF ALTERNATIVE RAIL-DEFECT REPAIR USING A BULLDOG CLAMP

TD 97-033

Summary

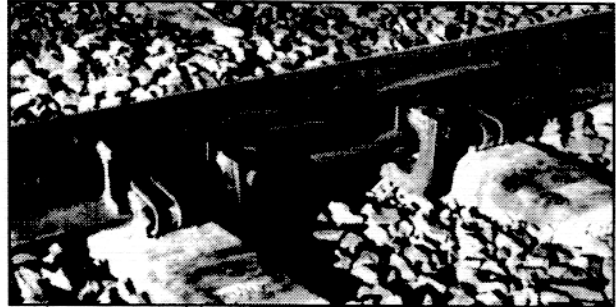
Exhibit 1. Bulldog-Clamp Repair of Defective Rail

The bulldog clamp is a modified set of angle bars held in place by C-clamps. Since the clamps do not require the use of bolts, crews do not drill holes in the rail, thus expediting repairs and increasing available track time.

The bulldog clamp provides protection equivalent to bolted angle bars, but with the significant advantage of eliminating the need for holes to be drilled into the rail (see Exhibit 1). The advantage is seen not only in reduced installation time of this remedial repair, but when the defect is removed, the potential exists for permanent repair using only one thermite weld rather than a plug and two thermite welds.
