Ultrasonic Wheel Crack Detection System Update

by Greg Garcia, John Tunna,
and Dane Hackenberger*

March 2001

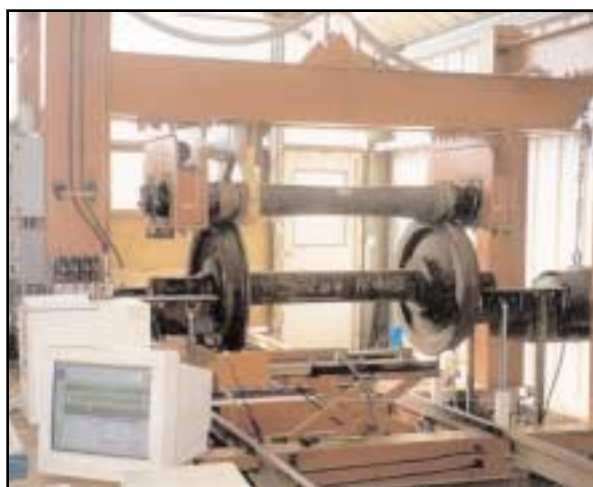
Exhibit 2. Shop Trial UT System Set Up

Phase II showed that by using high angle shear waves, flaws in the three wheel regions could successfully be detected. The results from this phase of research prompted the continued sponsoring of a shop trial system described in Phase III. An ultrasonic (UT) flaw detection system based on the parameters identified during Phase II research was designed and then installed into a car shop environment. The system shown in Exhibit 2 has been set up at the Norfolk Southern Corporation’s car shop in Hollidaysburg, Pa.

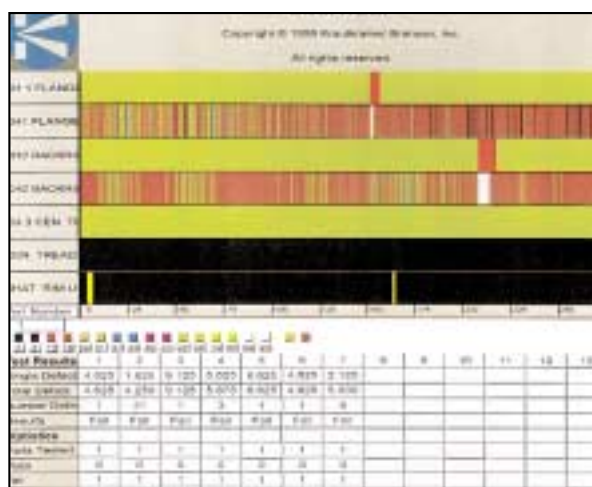
Exhibit 3. Graphical Display of a Wheel Inspection with the Shop Trial UT System

Approximately 150 to 200 wheels have been inspected (some repeats of the same wheel) using the UT system set up in the car shop. Wheel ultrasonic inspection data was stored using purpose-built ultrasonic data-logging software that provides a means to graphically view the data in a color bar chart format. The serial numbers of each wheel (correlated with a specific bar code for the wheel), the analog signal strength, and reject/accept areas were all recorded. The graphical display for a test wheel containing one defect in all three of the wheel regions is shown in Exhibit 3. Approximately 1,000 tests were performed and recorded by each test channel around the circumference of each wheel (i.e., each bar on the chart is made up of approximately 1,000 test scans).
