Using Acoustic Emission to Monitor Fatigue Cracks on the Bridge at FAST

by Shakoor Uppal, Dio Yoshino and *Hal L. Dunegan

Summary

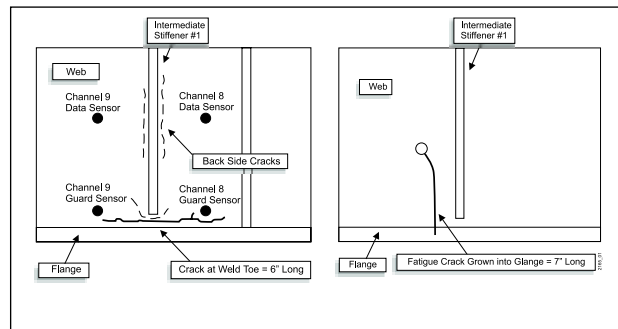
Exhibit 1. Location of Fatigue Cracks Monitored

The crack under intermediate stiffener 1 of girder 1 of span 2 (55 ft.6 in. long) and the crack near intermediate stiffener 6 of girder 1 of span 1 (65 ft. long), Exhibit 1, were selected for AE monitoring because they were the most active during the preliminary tests. Other NDE techniques have indicated that the first crack has run into the flange of the girder. The second crack is in both the weld and web and is growing at both ends. These cracks are referred to here as the "flange crack" and the "weld crack," respectively.

- The AE technique can be used to identify active fatigue cracks and to monitor their growth under heavy axle loads in steel bridges.
- On the bridge at FAST, a vertical crack at the flange (Exhibit 1) became dormant, whereas a crack at one of the welds (Exhibit 1) remained active in both directions. The growth at the right-hand side of the crack was much greater than at the left-hand side.

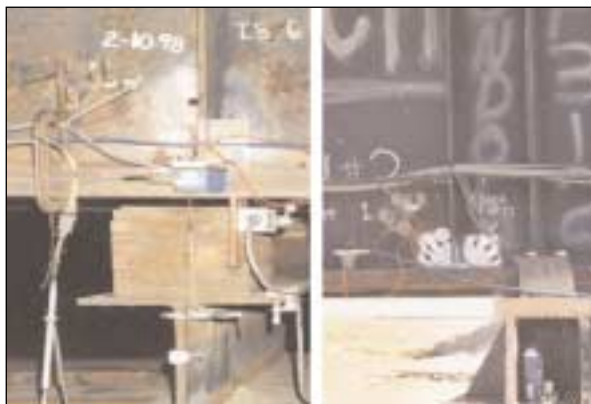
Exhibit 2. Instrumentation at Crack Locations

Data transducers and strain gages were installed at the weld crack and flange crack locations. In addition, a string potentiometer was installed under the flange crack location. This string potentiometer provided the number of cycles of displacement data that was correlated with the AE data from the flange crack. It also provided an indication of train presence over the bridge for the start and pause of data collection.

Each crack location had a "trigger" sensor located near the crack tip, and a "data" sensor located 10 inches from the trigger sensor. Each sensor collects both high and low frequency signals by using piezo-electric crystals. The purpose of using a trigger sensor in conjunction with a data sensor is to isolate a small area around the crack tip from which to collect AE signals. Transducers, strain gages, and a string potentiometer were connected to AE equipment as necessary to provide the parametric

inputs for recording data during different test runs. The system was on continuously, but the instrumentation was set up such that data was recorded only when the train was present on the bridge. Exhibit 2 shows the instrumentation at both crack locations, and Exhibit 3 shows the AE equipment in use.

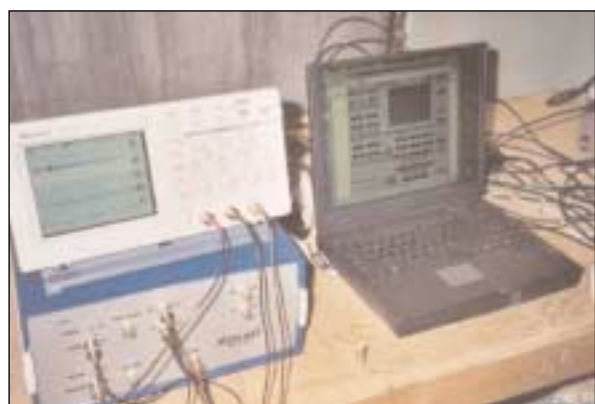
Exhibit 3. AE Equipment Used

Demonstrations conducted by TTCI and Dunegan Engineering Consultants Inc.(DECI) on the bridge at FAST in November 1999 and June 2000 demonstrated that this problem could be successfully overcome with the use of new 10-channel AESMART 2000™ equipment. This equipment utilizes modal analysis of the acoustic emission signals to separate crack-growth related signals from extraneous noise by setting adequate high to low frequency ratios.

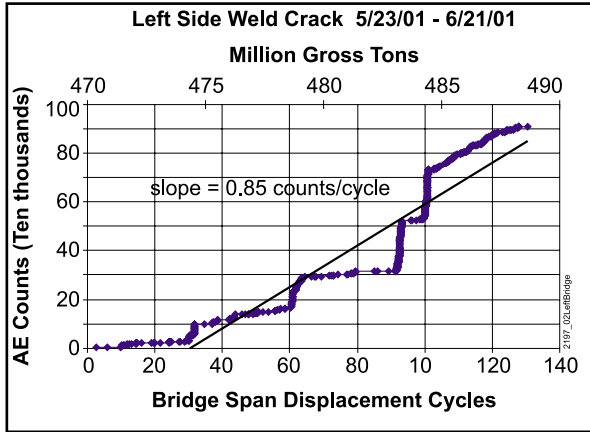
Exhibit 4. Summation of AE Counts vs. Loading Cycles, Weld Crack Left

Exhibits 4 and 5 show the summation of counts as a function of cycles from the transducers placed on the left- and the right-hand side of the weld crack, respectively. The crack appears to be much more active on the right-hand side than the left-hand side as evidenced by a higher density of signals and a higher number of counts per cycle. This correlates with growth measured by visual inspection. It should be noted that the growth of the crack tips as determined by visual inspection were not linear as indicated in the exhibits but grew in a stepwise manner. The AE data collected does not always correlate with an increase in crack length because a crack may be growing in depth instead of length. The stepwise nature of the AE data from the bridge is believed to be due to formation of a plastic zone between the crack growth occurrences that act as temporary barriers. The slope of the plots represents the rate of crack growth. An accelerated increase in slope is an indicator of increase in the stress intensity factor K, and therefore the crack growth rate increasing. On the other hand, a decrease in the slope is an indicator that crack arrest may occur. The location of the fatigue crack in conjunction with its growth and the geometry of the structure could be used to determine the urgency of maintenance of a bridge.

During 2001 monitoring, no AE activity was measured at the flange crack indicating that after propagating into the thick flange, this crack had become dormant. On the other hand, the weld crack showed a lot of AE activity and grew in both directions.
